Research Report 246

Traffic induced vibrations in buildings

by G R Watts

RESEARCH REPORT 246

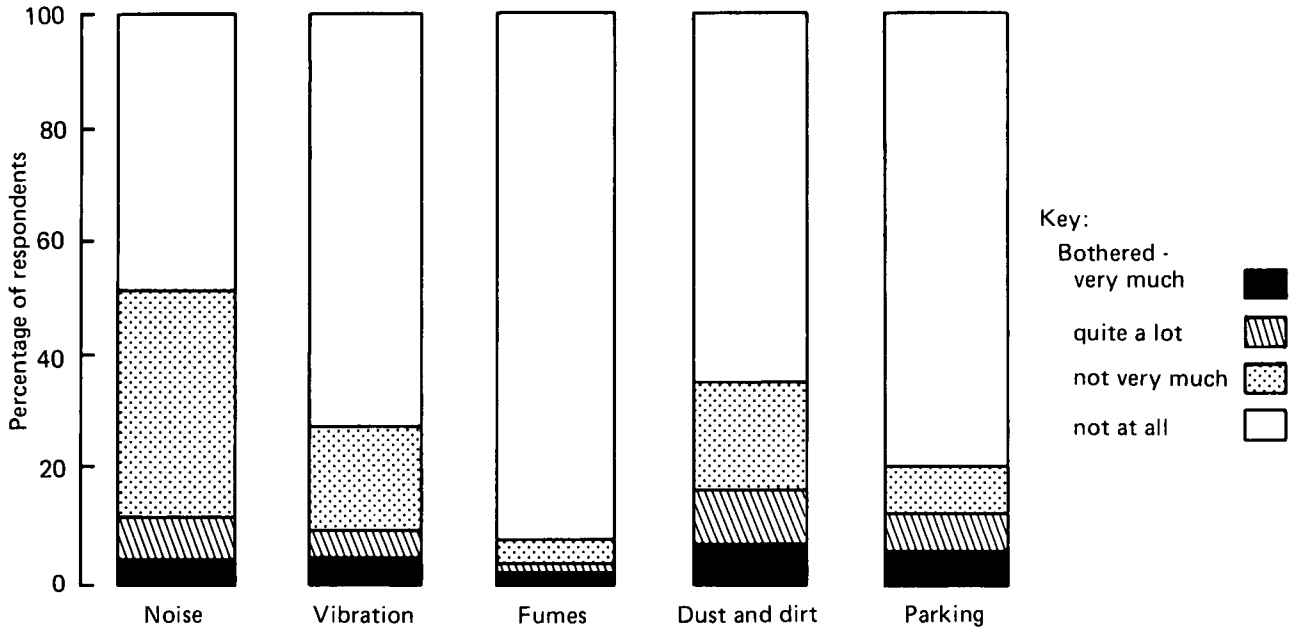
Fig.1 Percentage bothered in the home by type of disturbance caused by traffic
 Source: Morton - Williams et al 1978

noise, fumes and dust and dirt. Figure 1 shows the percentage of respondents bothered to varying degrees by the type of disturbance. In terms of the number of people bothered it can be seen that vibration disturbance is not as prevalent as that due to noise and dust and dirt. If the percentage disturbed is plotted against traffic flow (Figure 2) it can be seen that at higher traffic levels vibration becomes relatively more disturbing compared with other nuisances. This probably results from the fact that once vibration is perceived any further increase in level of exposure rapidly becomes intrusive whereas in the case of noise there is a more gradual increase in annoyance with increasing level. This consideration will be examined further in Section 3.6 where vibration thresholds are discussed.

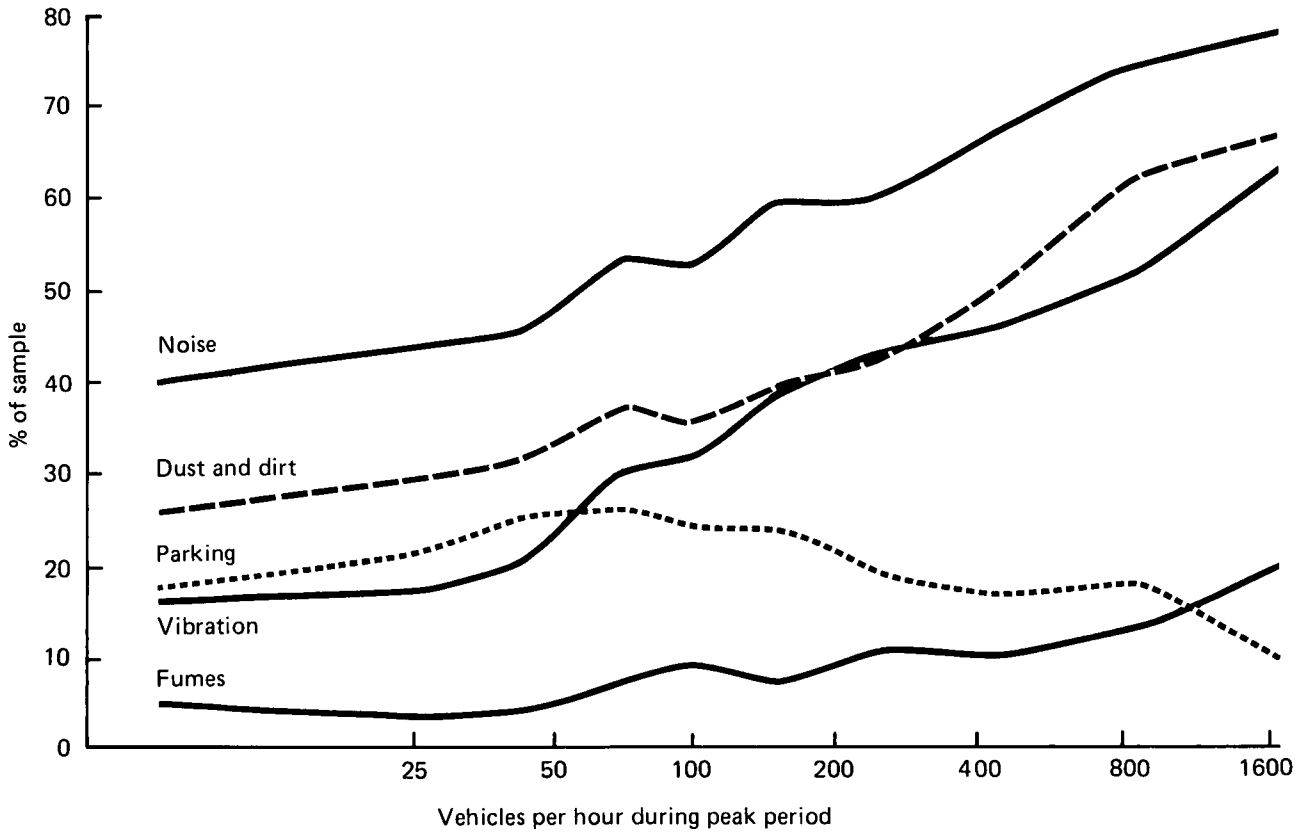
Fig.2 Percentage of respondents bothered in the home by various disturbances by traffic flow
 Source: Morton - Williams et al 1978

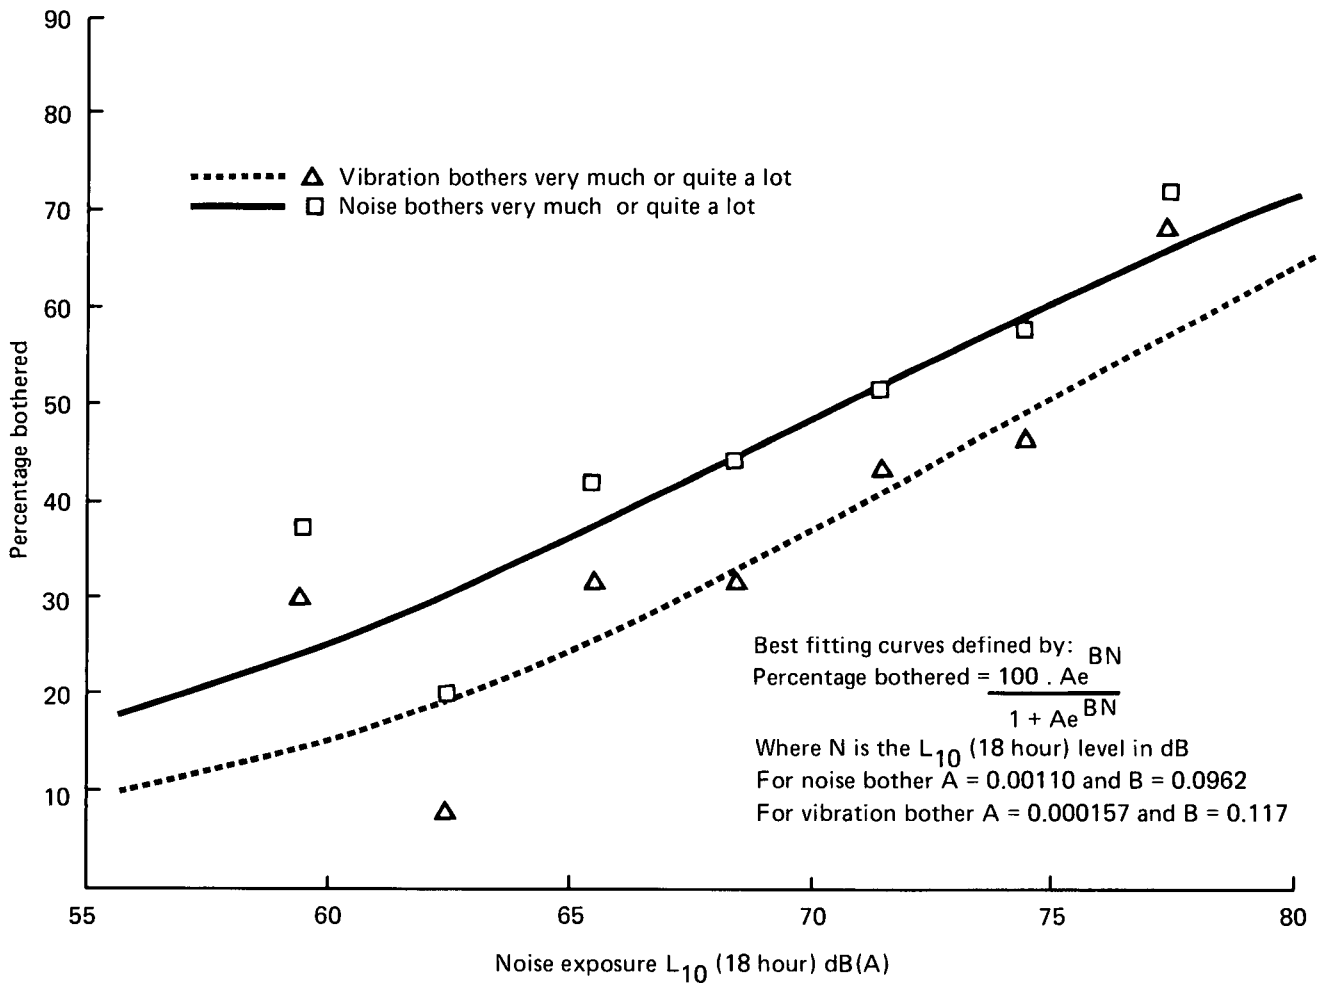
Fig.3 Percentages of respondents bothered by noise and vibration caused by traffic

In a further analysis (Watts, 1985a) the average percentage of residents bothered by vibration and noise at various levels of noise exposure (using the L₁₀ (18-hour) dB(A) scale) was calculated (Figure 3). The large fluctuation at low exposure levels is probably due to sampling error since only a small number of sites was used to compute the percentage bothered. It was considered that a sigmoid curve was the most appropriate function to describe these data and the best fit was obtained by taking the logit transformation of the percentages and using least squares analysis. It can be seen from the figure that at a given value of L₁₀ (18-hour) a higher percentage of respondents were disturbed by noise than vibration effects and this is true throughout the noise exposure range sampled. This result is in agreement with the findings of the national survey where it is likely that traffic flow was acting as a proxy for vibration exposure (see Section 3.1 and Figure 2). A similar trend of percentage bothered with noise (ie more than 'moderately annoyed') with exposure has also been reported (Fields and Hall, 1987).

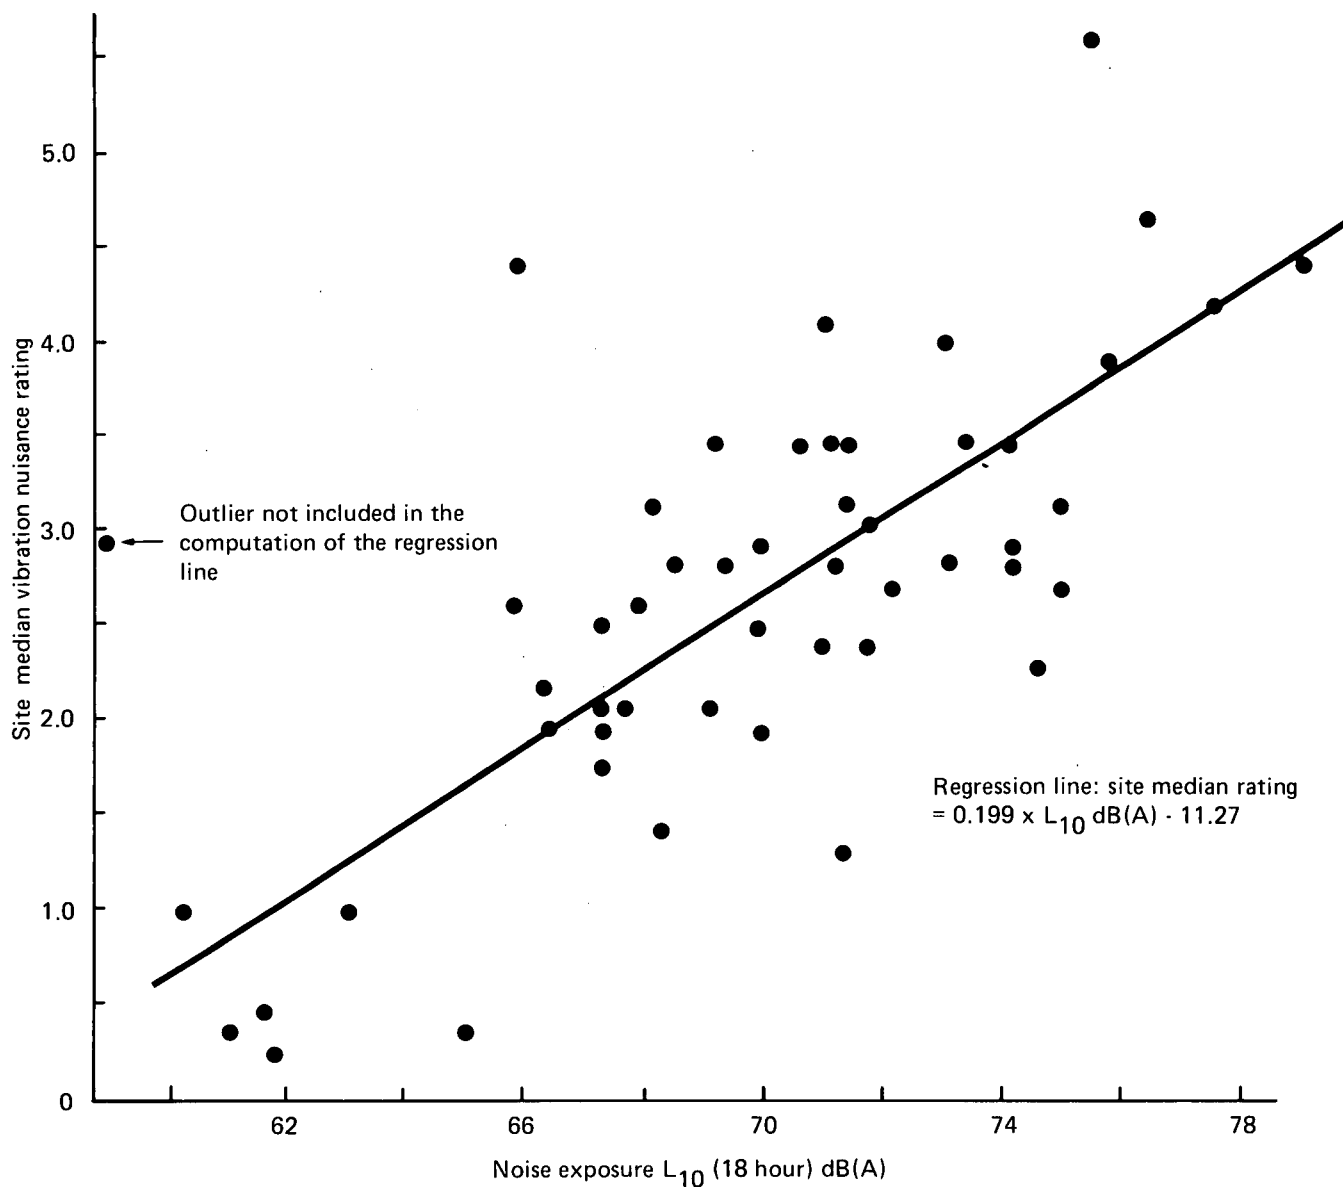
Fig.4 Median vibration nuisance rating and L₁₀ (18 hour) dB(A)

ratings and therefore are an indicator of overall site nuisance. It was found that the highest correlations were obtained with the various 18-hour noise measures which are listed in Table 4. Of the measure examined, the Leq 18-hour was most closely associated with the median vibration nuisance rating ($r=0.71$). It was expected that a low frequency noise measure would be most closely related to these disturbance scores since this noise has been shown to be responsible for the common manifestations of vibrations such as window and door rattles. These noise measures were in fact marginally less well correlated than the dB(A) index, but there are no statistically significant differences between any of these correlations. Figure 4 shows a scatter plot for the L₁₀ (18 hour) dB(A) index. This index is widely used for the assessment of traffic nuisance. The regression line is based on data from 49 sites, not 50, since at one quiet site adverse reactions were thought to have been caused by the recent

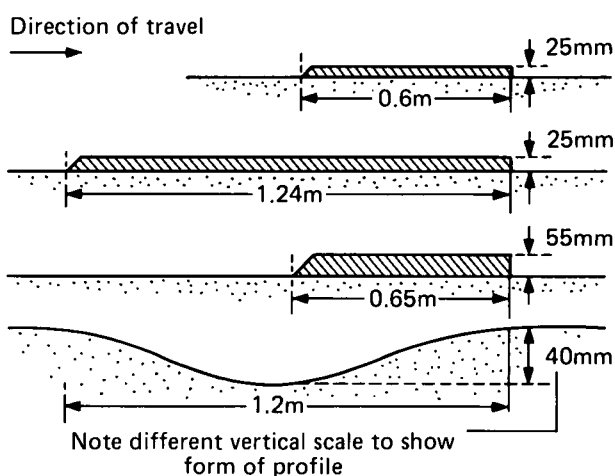
Fig.5 Test profiles

Note: Except for these test irregularities, the track had a level surface to within $\pm 7\text{mm}$ within 5m of the mid profile position

Eight HGVs, comprising rigid and articulated vehicles, were tested by running the vehicles over artificial humps and a depression on the TRRL research track. The suspension systems for the trailers covered a wide range and included two and three axle bogies with steel and air suspension and a two axle rubber sprung system. The vehicles were tested at speeds up to 80 km/h fully laden and empty over a range of profiles. These were designed to represent a wide variety of surface defects resulting from poorly backfilled holes and trenches on public roads. Figure 5 gives details of these profiles. The particle velocities produced on the track surface by ground vibrations were measured by triaxial geophone arrays fixed at 2 metres and 6 metres from the nearside wheel paths.

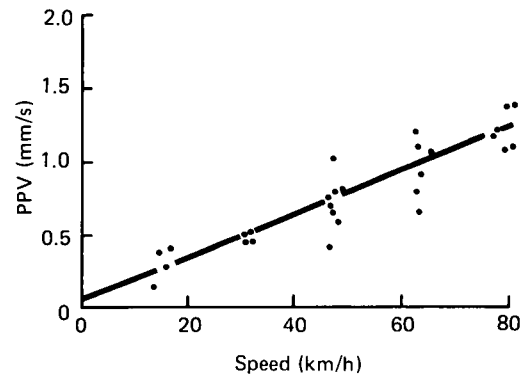
Fig.6 Vertical PPV at 6m with vehicle speed over 0.6m x 25mm hump - TRRL hump

Figure 6 shows a plot of vertical PPV at 6m against speed for the range of fully laden HGVs running over the 0.6 m x 25 mm high profile. There is a scatter of results indicating differences in the vibration produced by the various vehicles, but the trend with speed is clearly defined. For simplicity the differences between vehicles are not included in the model and the linear regression line was used to establish the relationship with speed. Further tests were made with smaller two axle vehicles ranging from a small estate car to a tipper lorry. As expected these vehicles generally produced lower peak levels. This can be seen in Figure 7 where PPV is plotted against gross vehicle weight for the same profile and crossing speed that were used in the HGV tests. There is an obvious trend of rising PPV with increasing vehicle weight. Since the main aim was to predict the maximum likely PPV in a stream of traffic, these smaller vehicles were not considered in the development of the prediction model.

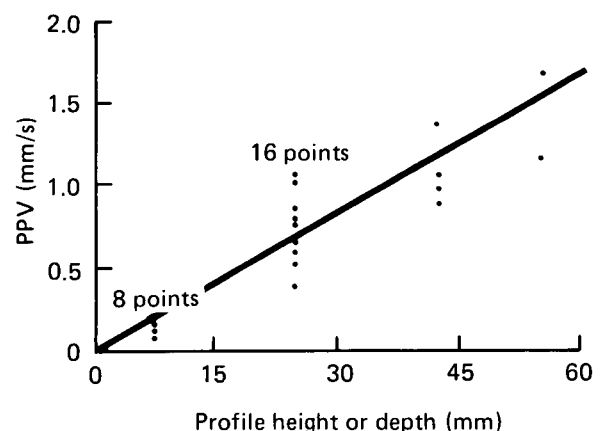
Fig.8 Vertical PPV at 6m with profile height or depth at 58 km/h - TRRL track

In Figure 8 the vertical PPVs at 6 m produced by each fully laden HGV travelling over the profiles at 48 km/h are plotted against the maximum height or depth of the profile. It can be seen that this dimension of the profile is a reasonable indicator of the likely PPV despite the wide range of profile shapes employed. Linear regression analysis showed that the average PPV at 6 m for a 25 mm high profile was 0.7 mm/s, the slope being 0.028 mm/s per mm increase in height or depth. The trend with speed over the 25 mm high profile is linear to a good approximation (Figure 6) and

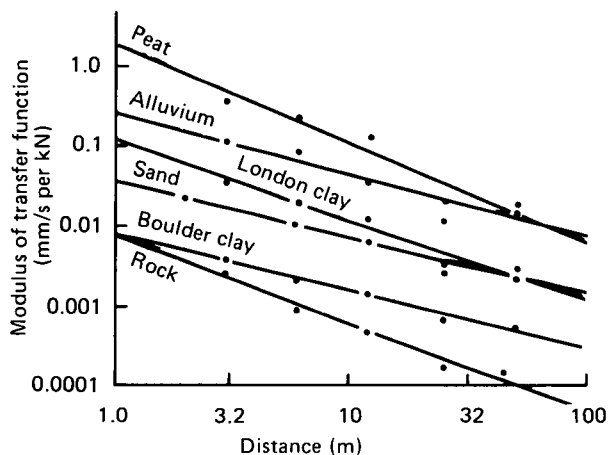
Fig.9 Transfer function for vertical PPV at 12 Hz by distance

Figure 9 shows how the moduli of the transfer functions at 12 Hz vary with distance for six different ground conditions. The Figure clearly shows that there is a large difference of up to two orders of magnitude between the response of a soft soil (peat) and very hard ground (chalk rock). Linear regression lines were fitted to the logarithmic transform of the data at 12 Hz for each site and the correlation coefficients ranged from 0.922 to 0.998, indicating good agreement with an attenuation model based on a simple power law r^x , where x is the power coefficient. Table 7 shows that there is a range of power coefficients even for similar soil types. This table also gives the average moduli of the transfer function at 6 m for six ground conditions, together with the corresponding values expected at building foundations.

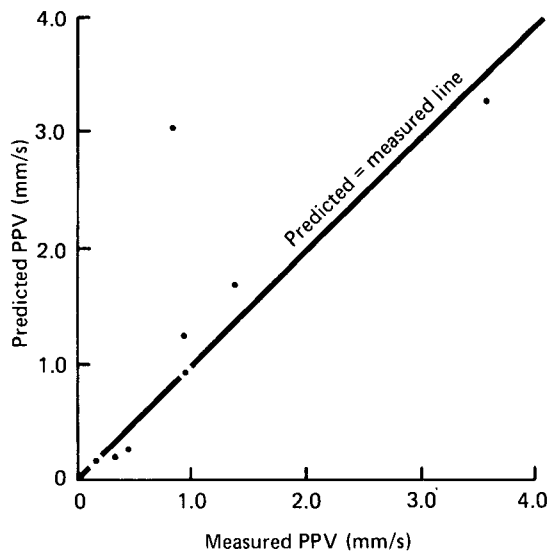
Fig.10 Measured and predicted maximum vertical PPVs at building foundations due to HGVs passing over road surface irregularities

The method is based on making predictions of vertical PPV at 6 m using the observed trends with amplitude of road surface irregularity and speed, and the most appropriate ground scaling factor. By combining these factors the expected value of maximum vertical PPV at a building foundation can be calculated as:—

$$0.028.a.(v/48).t.p.(r/6)^x$$

Where a = maximum height or depth of the surface defect in mm, v = maximum expected speed of HGVs in km/h and t = ground scaling factor (see Table 7). If the surface defect occurs in one wheel path only then $p = 0.75$, otherwise $p = 1$, r is the distance of the foundation from the defect in metres and x = power factor, which can be obtained from Table 7 for the most appropriate soil type.

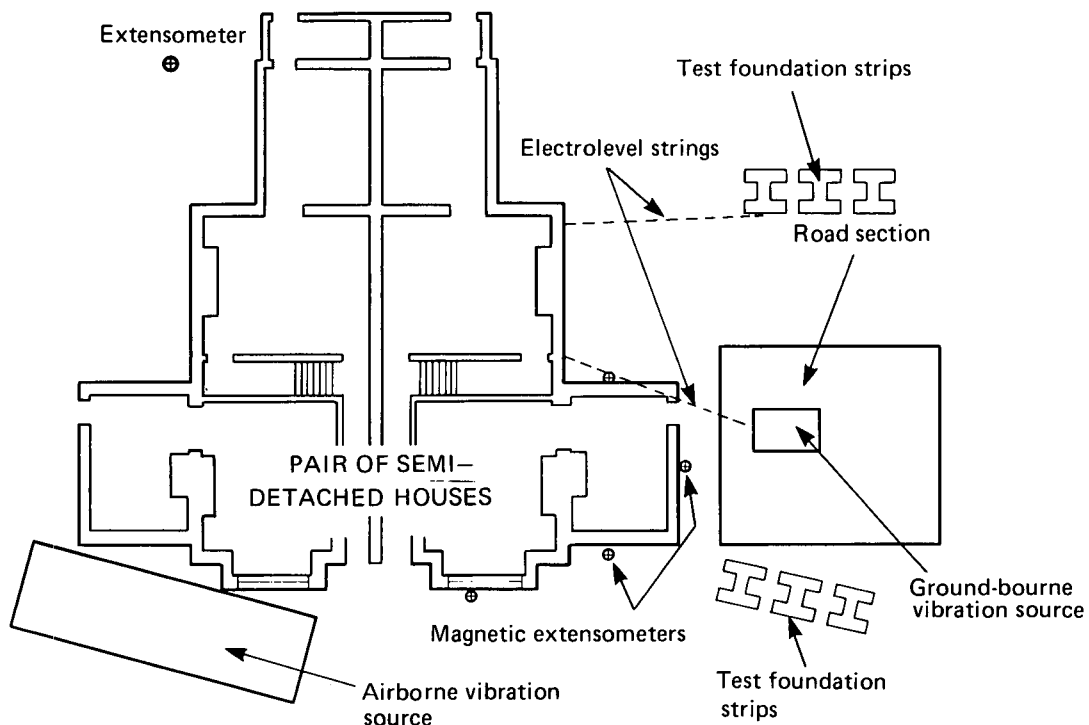
Fig.11 Site layout for fatigue test of a pair of semi-detached houses

The test building was a recently vacated pair of semi-detached houses built on medium density sands. The sand was loose down to a depth of approximately 1.5 m and below this level it was lightly cemented. The houses were built at the beginning of the century and were constructed of brickwork in lime mortar. Test foundation strips were also constructed so the effects of ground-borne vibration on foundations under different static loads could be investigated. The general layout of the site is shown in Figure 11.

Airborne traffic vibration was simulated using four large loudspeakers mounted in the wall of a high sided refrigerated lorry parked adjacent to the house facade (Figure 11). A computer was used to generate a low frequency waveform which when suitably amplified produced a peak linear sound level of 110 dB at the facade. Initially the system was used to generate a broad band noise characteristic of heavy goods vehicles but the resulting vibration was lower than expected. In order to create higher vibration levels the frequency was adjusted to produce resonance in the window adjacent to the loudspeaker system.

Ground-borne traffic vibration was simulated using a geophysical vibrator located 2 m from a side wall of the building (Figure 11). Levels were adjusted so that the vertical PPV at foundation level adjacent to the vibrator was in the range 2.5–3.0 mm/s. This is close to the extreme end of the range of peak velocities that have been recorded in buildings close to significant road surface irregularities during the passage of heavy vehicles (see Section 3.4.4). The frequency was adjusted to approximately 13 Hz, which is within the range of frequencies produced by HGVs, and this input produced a relatively large response in the structure. Figure 13(a) and (b) show the time

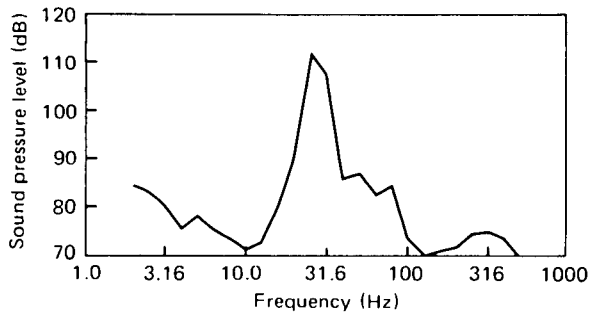
Fig.12 Third octave sound levels in gap between speaker array and facade - house fatigue test

Figure 12 shows that the principal frequencies of the simulated sound lay in the 25 Hz third octave band. By carrying out this adjustment the generated vibration levels were at or above the highest levels likely to be produced by vehicles passing close to a building. During the experiment it was estimated that the simulation produced an exposure to noise equivalent to the passage of approximately 500 000 HGVs.

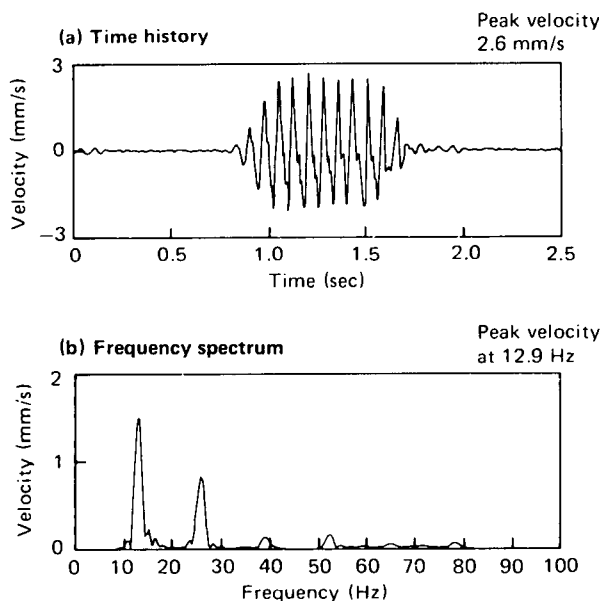
Fig.13 Vertical particle velocity at foundations adjacent to vibrator - house fatigue test

history and frequency content of a typical pulse. The house was exposed to 880 000 such pulses which was estimated to have simulated the effect of over 3.5 million HGVs axles passing over a large surface irregularity near the house.

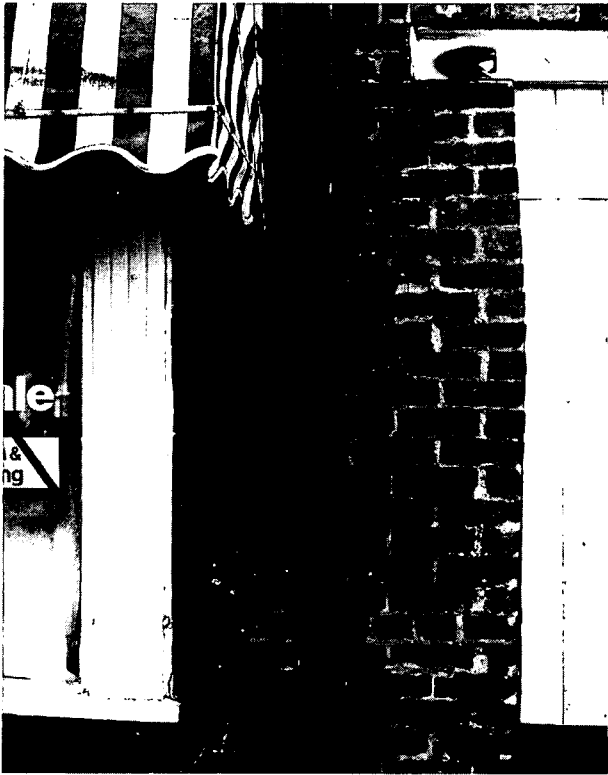
Plate 1 Entrance to Waggon Porch in Shrimpers cottage showing vertical crack

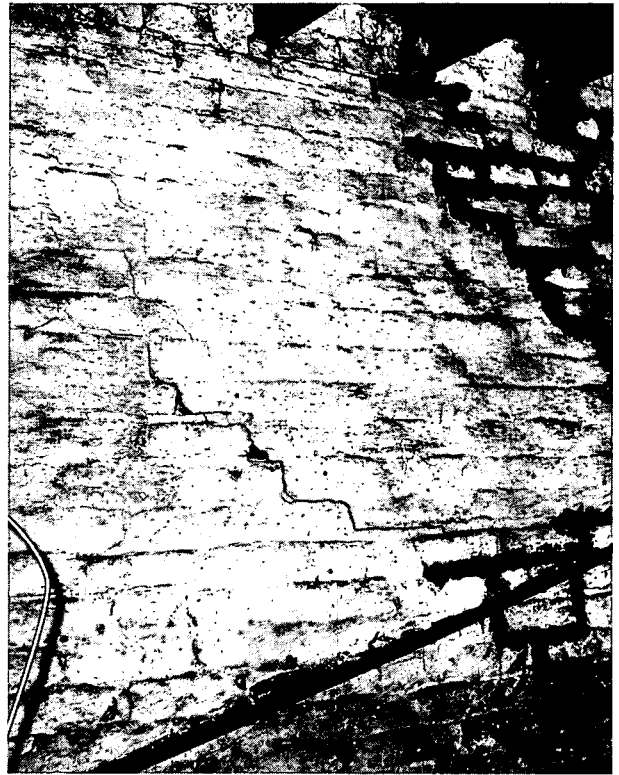
Plate 2 Side wall of Waggon Porch showing extensive cracking

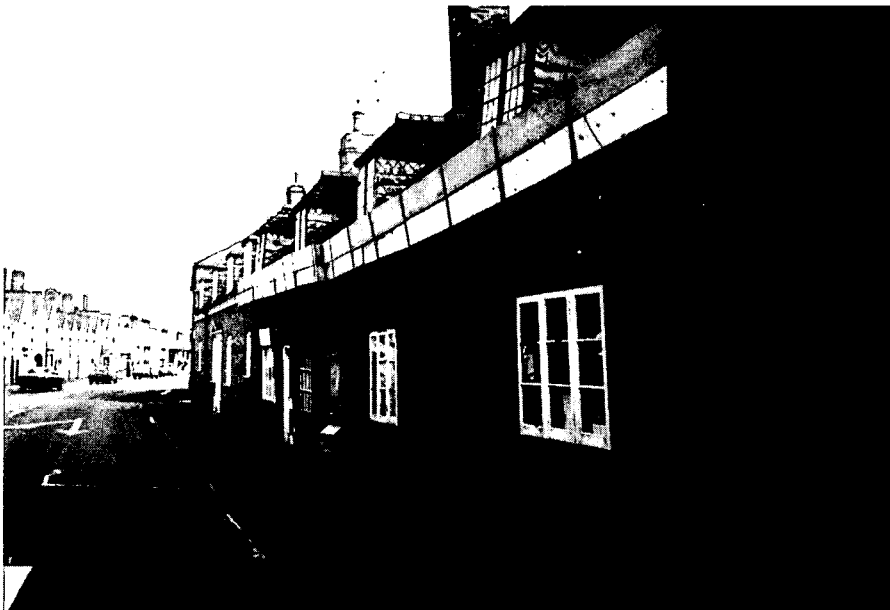
Plate 3 Out of plumb wall adjacent to A47 at Thorney

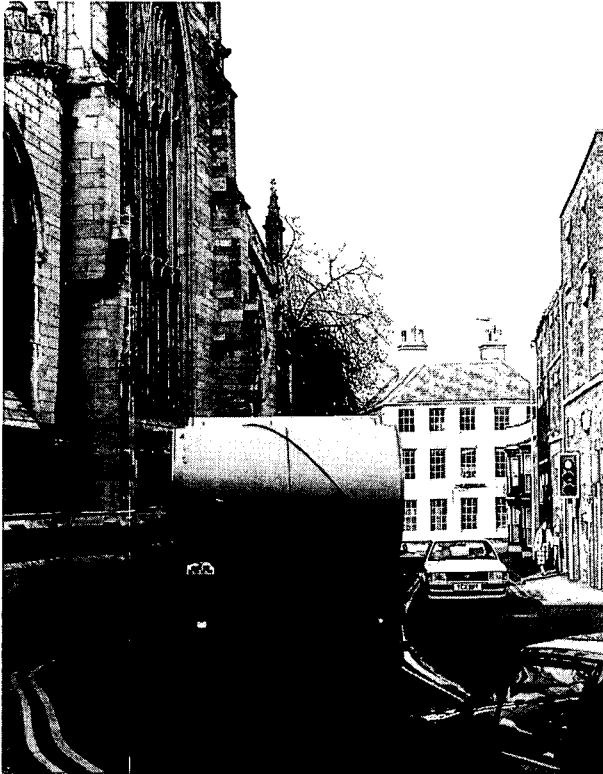
Plate 4 15th century parish church adjacent to A16 at Louth

east end of this large building since some windows were heard to buzz and rattle as vehicles passed by. This anxiety was understandable since this end of the church is within two metres of the heavily trafficked A16 (Plate 4). Since the church was very large it was feasible to compare windows near the west end, which were not exposed to such high vibration levels, with the windows at the east end. Detailed examination showed that there were no differences in the condition of the windows which could reasonably be explained by exposures to traffic vibration.

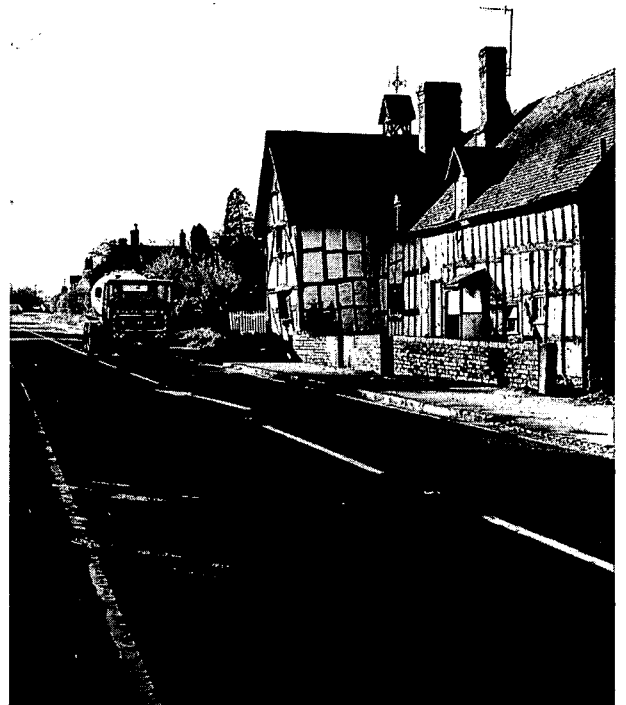
Plate 5 15th century timber framed building adjacent to A435 at Norton near Evesham

This cottage was situated close to the heavily trafficked A435 and Plate 5 shows a pronounced distortion of the gable wall adjacent to the carriage way. Distortions of this type are not uncommon in this type of building and a similar building was found in Evesham which had even more severe distortion and yet was well removed from any main road. The cottage can be identified in a photograph published in a touring guide in 1954 and the distortion can be seen, although it is not possible to quantify the degree of tilt with any degree of accuracy. However it is evident that the distortion is not new and cannot plausibly be attributed to modern heavy traffic.

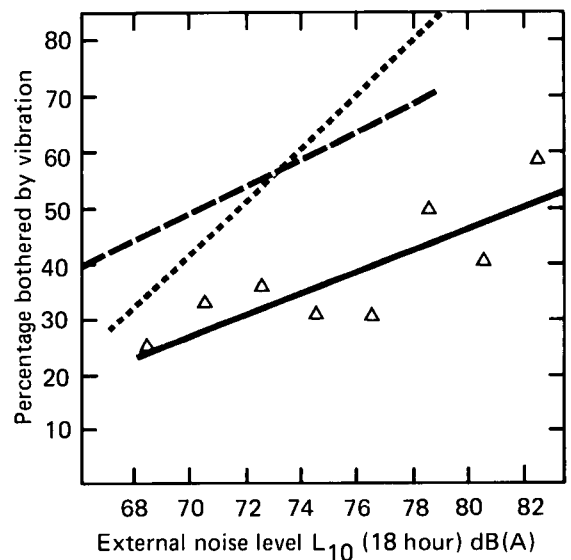
Fig. 14 Percentage of respondents bothered by vibration

Figure 14 shows the trend in the percentage of residents 'bothered by vibration' with noise exposure level. The TRRL data was taken as part of the 50 site survey where most dwellings had single glazing. This data is compared with results from a Building Research Establishment survey (Utley et al, 1986) where all dwellings were fitted with double windows which had been installed as part of the insulation package available under the Noise Insulation Regulations. The TRRL survey

- BRE data. Houses along dual carriageways fitted with double windows
 $Y=1.9X - 105.6; r=0.83$
- TRRL data, Houses along dual carriageways, mainly single glazing: $Y=4.71X - 287.4; r=0.90$
- - - TRRL data. Houses at all sites, mainly single glazing: $Y=2.36X - 116.0; r=0.64$
