CAMBOURNE TO CAMBRIDGE

Environmental Statement

Technical Report 5: Ecology, Appendix 5.16:
Arboricultural Technical Note (Draft)

Arboricultural Technical Note

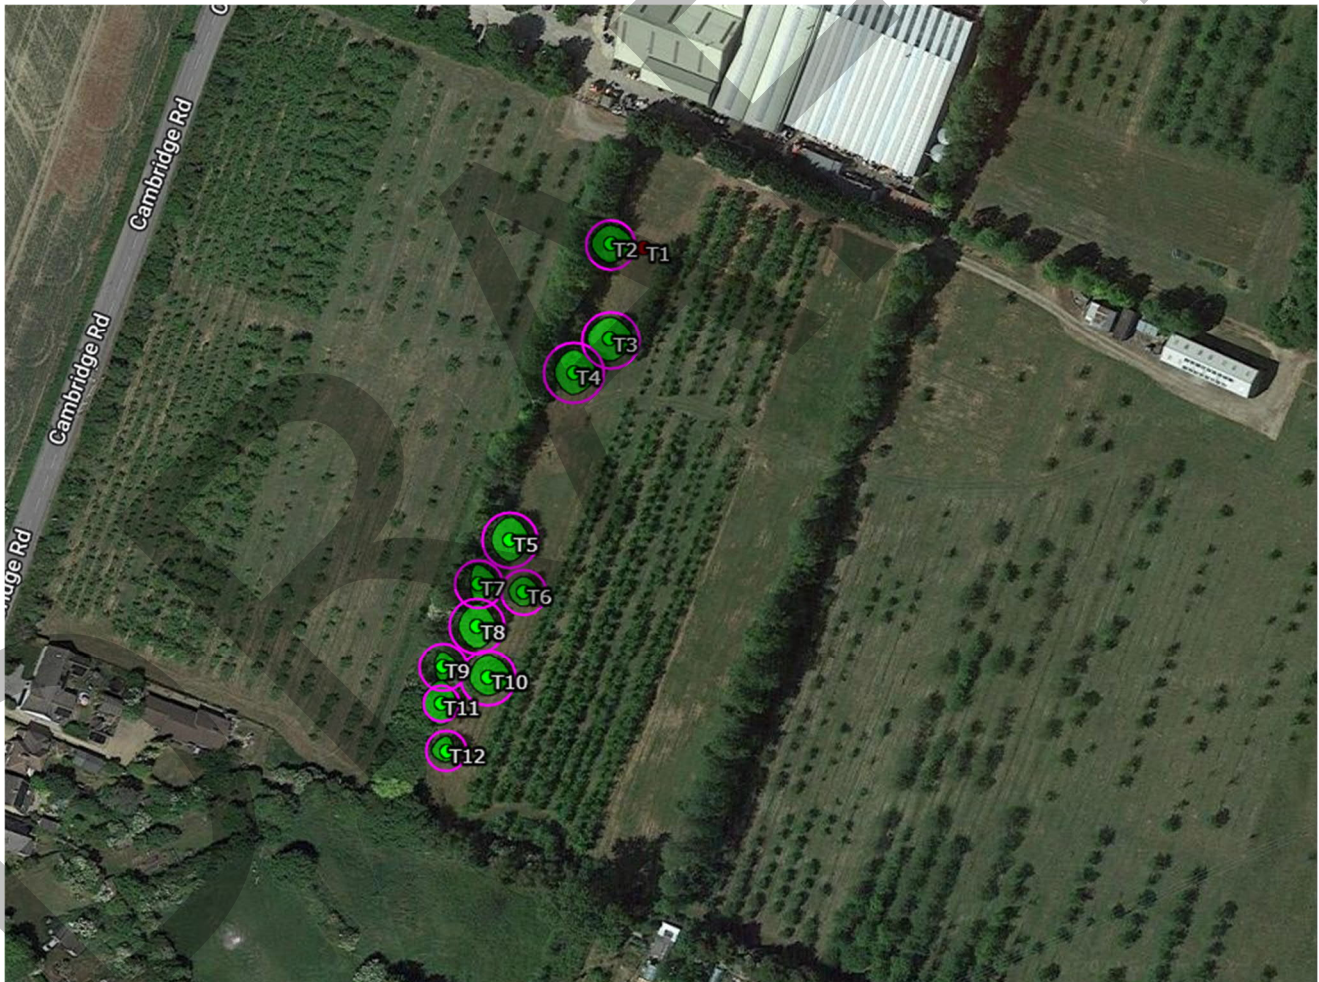
Figure 1: Coton Orchard, apple trees

5.1.3 One area of the orchard contains old trees, possibly dating from the foundation of the orchard (or soon after) a century ago (see Annex, figure 1). The importance of traditional orchard as an ecological resource is because the open-grown trees provide a matrix of arboricultural and grassland habitats.

5.1.4 There are 11 live specimens of old apple tree. An elder is growing from the stump of what was once a twelfth tree (referenced as T1 but not qualifying for classification under BS5837).

5.1.5 Apple trees of approximately 100 years could reasonably be considered veteran because their lifespan is beyond that of most specimens of the species. However, the apple trees have received regular crown pruning which has rejuvenated branch growth and the crowns have not retrenched. Moreover, pruning has limited the development of a wide trunk (relative to untended old specimens of the species). Hollowing of the trunks is very extensive. Some exhibit brackets of decay fungi. The arboriculturist concluded that the trees do not possess sufficient of the key criteria of veteran trees, but this is not to say that they do not provide an important ecological resource as deadwood habitat and the combination of open grown trees and ground flora provides a priority habitat.

5.1.6 The trees have an estimated remaining contribution of at least 20 years. Typically, BS5837 requires that trees have an anticipated 40+ years of expected life to be accorded high quality/category A status. However, there is scope for A categorisation with sub-category 3, reflecting high cultural importance, to be applied in this context. Moreover, the arboricultural categorisation does not capture the full ecological consideration.

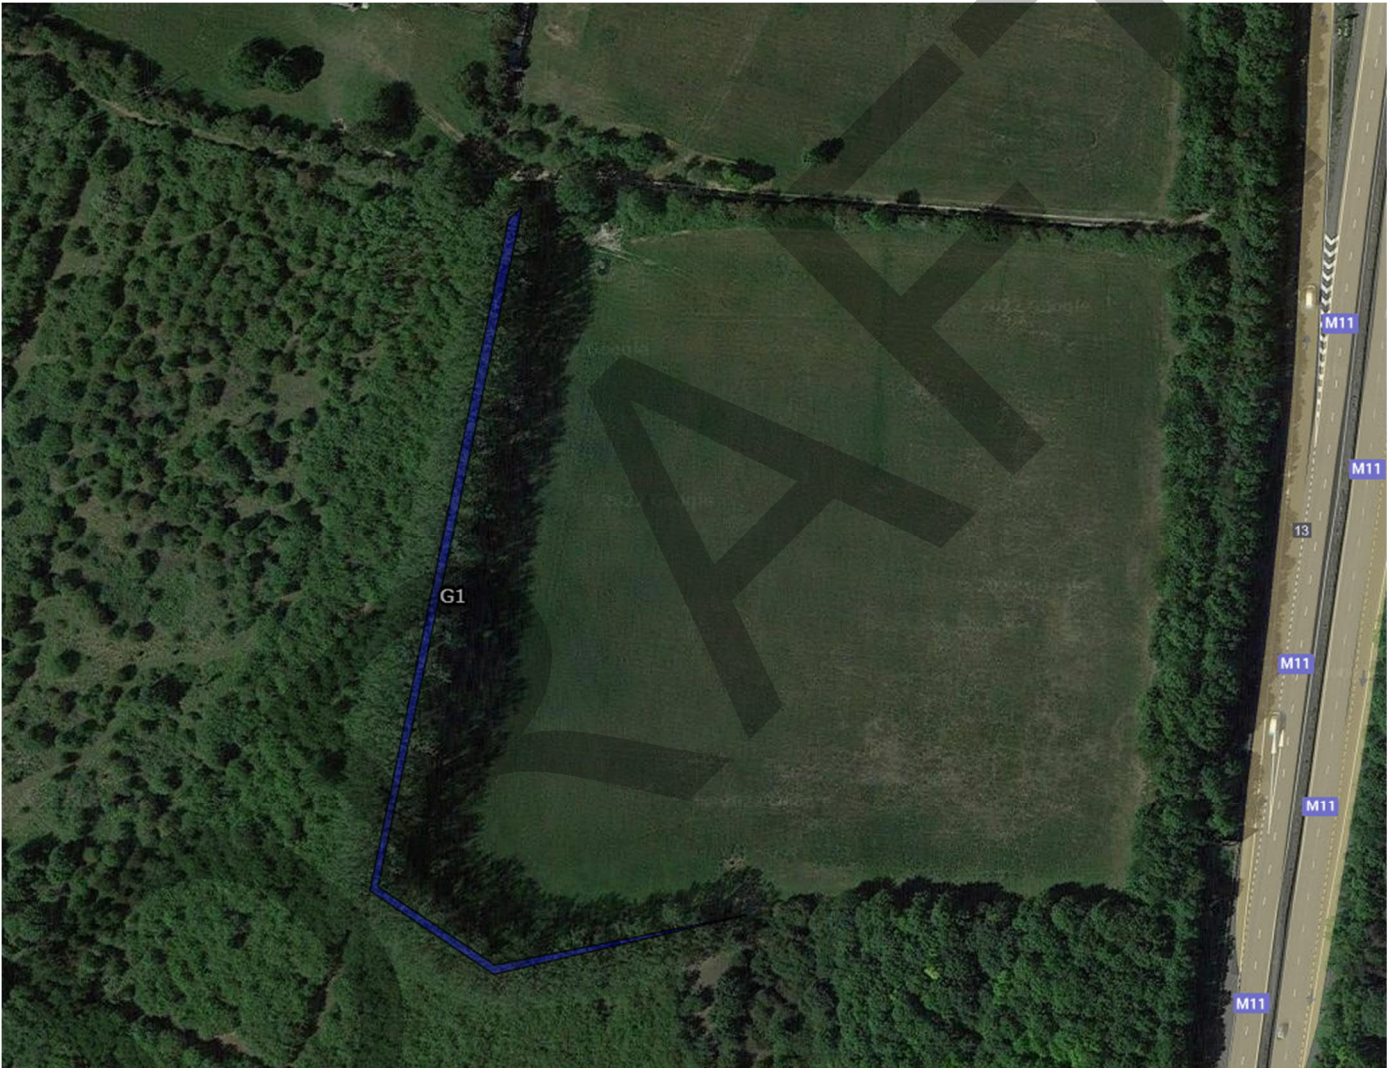
Figure 2: Poplar trees at Coton Orchard

- 6.1.1 The fruit trees of Coton Orchard give way to low quality scrub woodland in the eastern parcel of the site (see Annex, figure 2). On the eastern boundary of the land parcel is a line of poplar trees at very close spacing. The stems are typically between 1 and 3m separation and grow along the top of a ditch. The group has an understorey of hawthorn.

- 6.1.2 A small number of the poplar trees have been blown over. The closely spaced trees and the ditch have significantly restricted rooting and incipient tree instability is anticipated. The trees are tall to 26m and have stem diameters of up to 900mm (with most stems in the range 600-700mm). Collectively the trees form a moderate quality/B category group but individually the trees are of low quality/C category.

- 6.1.3 Removal of a section of the group or selective thinning of the poplar tree group will increase instability of retained trees, as there is currently some mutual physical support. Topple distance in excess of one tree length to a routeway should be maintained.

- 6.1.4 Reduction in topple distance, to allow for greater tree retention, may be possible through pollarding, the act of tree height reduction from which branch regeneration and regrowth follows. Poplar responds well to this recognised management technique, but the process requires repeated actions on a cycle of 5-10 years and left unattended, after pollarding, increases the potential for branch drop.

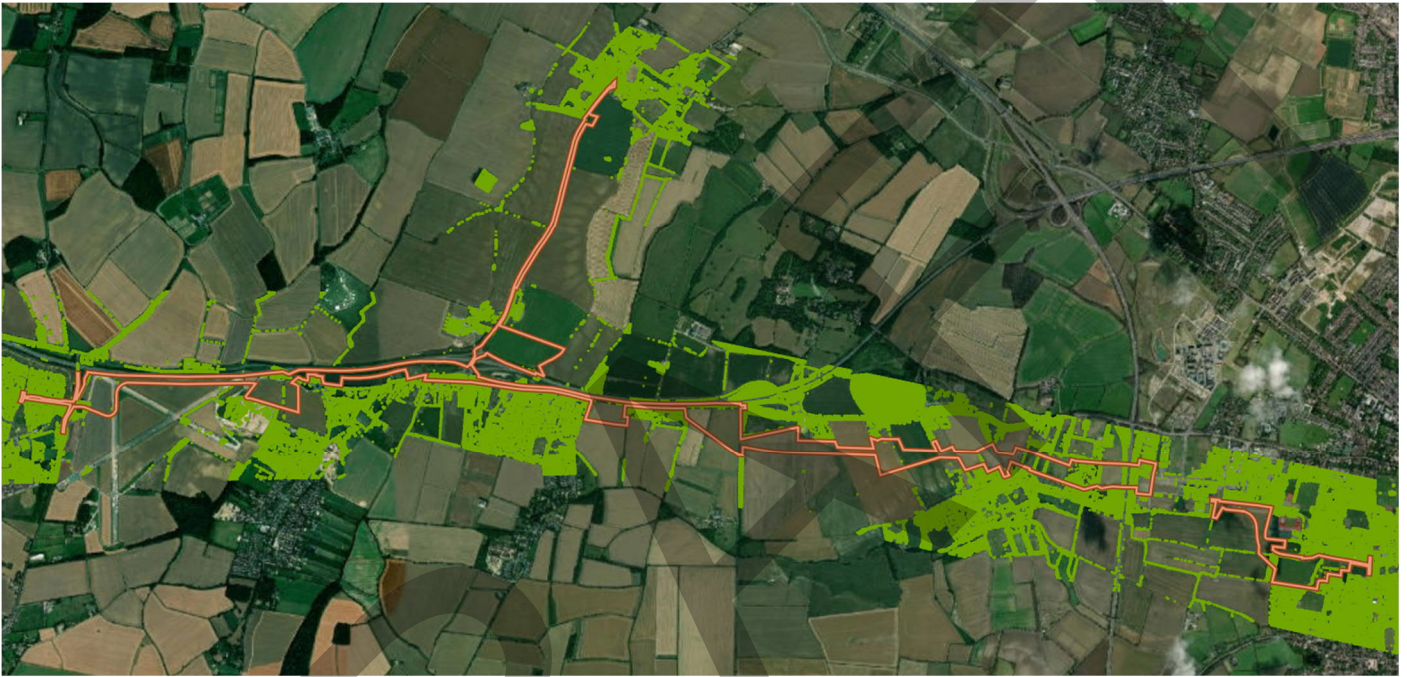
Figure 3: Scheme-wide LiDAR vegetation capture

- 8.1.1 A LiDAR analysis was undertaken to determine the heights and spreads of trees within the boundary of the proposed development (See Annex, figures 3 and 4). This has identified a limited number of trees on Scotland Road and in suburban settings and third-party garden land.
