CAMBOURNE TO CAMBRIDGE

Technical Report 11, Appendix TR11.1: Mott
MacDonald Geotechnical and Geo-environmental
Preliminary Risk Assessment

Geotechnical and Geo-environmental Preliminary
Risk Assessment

Document reference: 392438-MMD-HWA-XX-RP-GE-0001

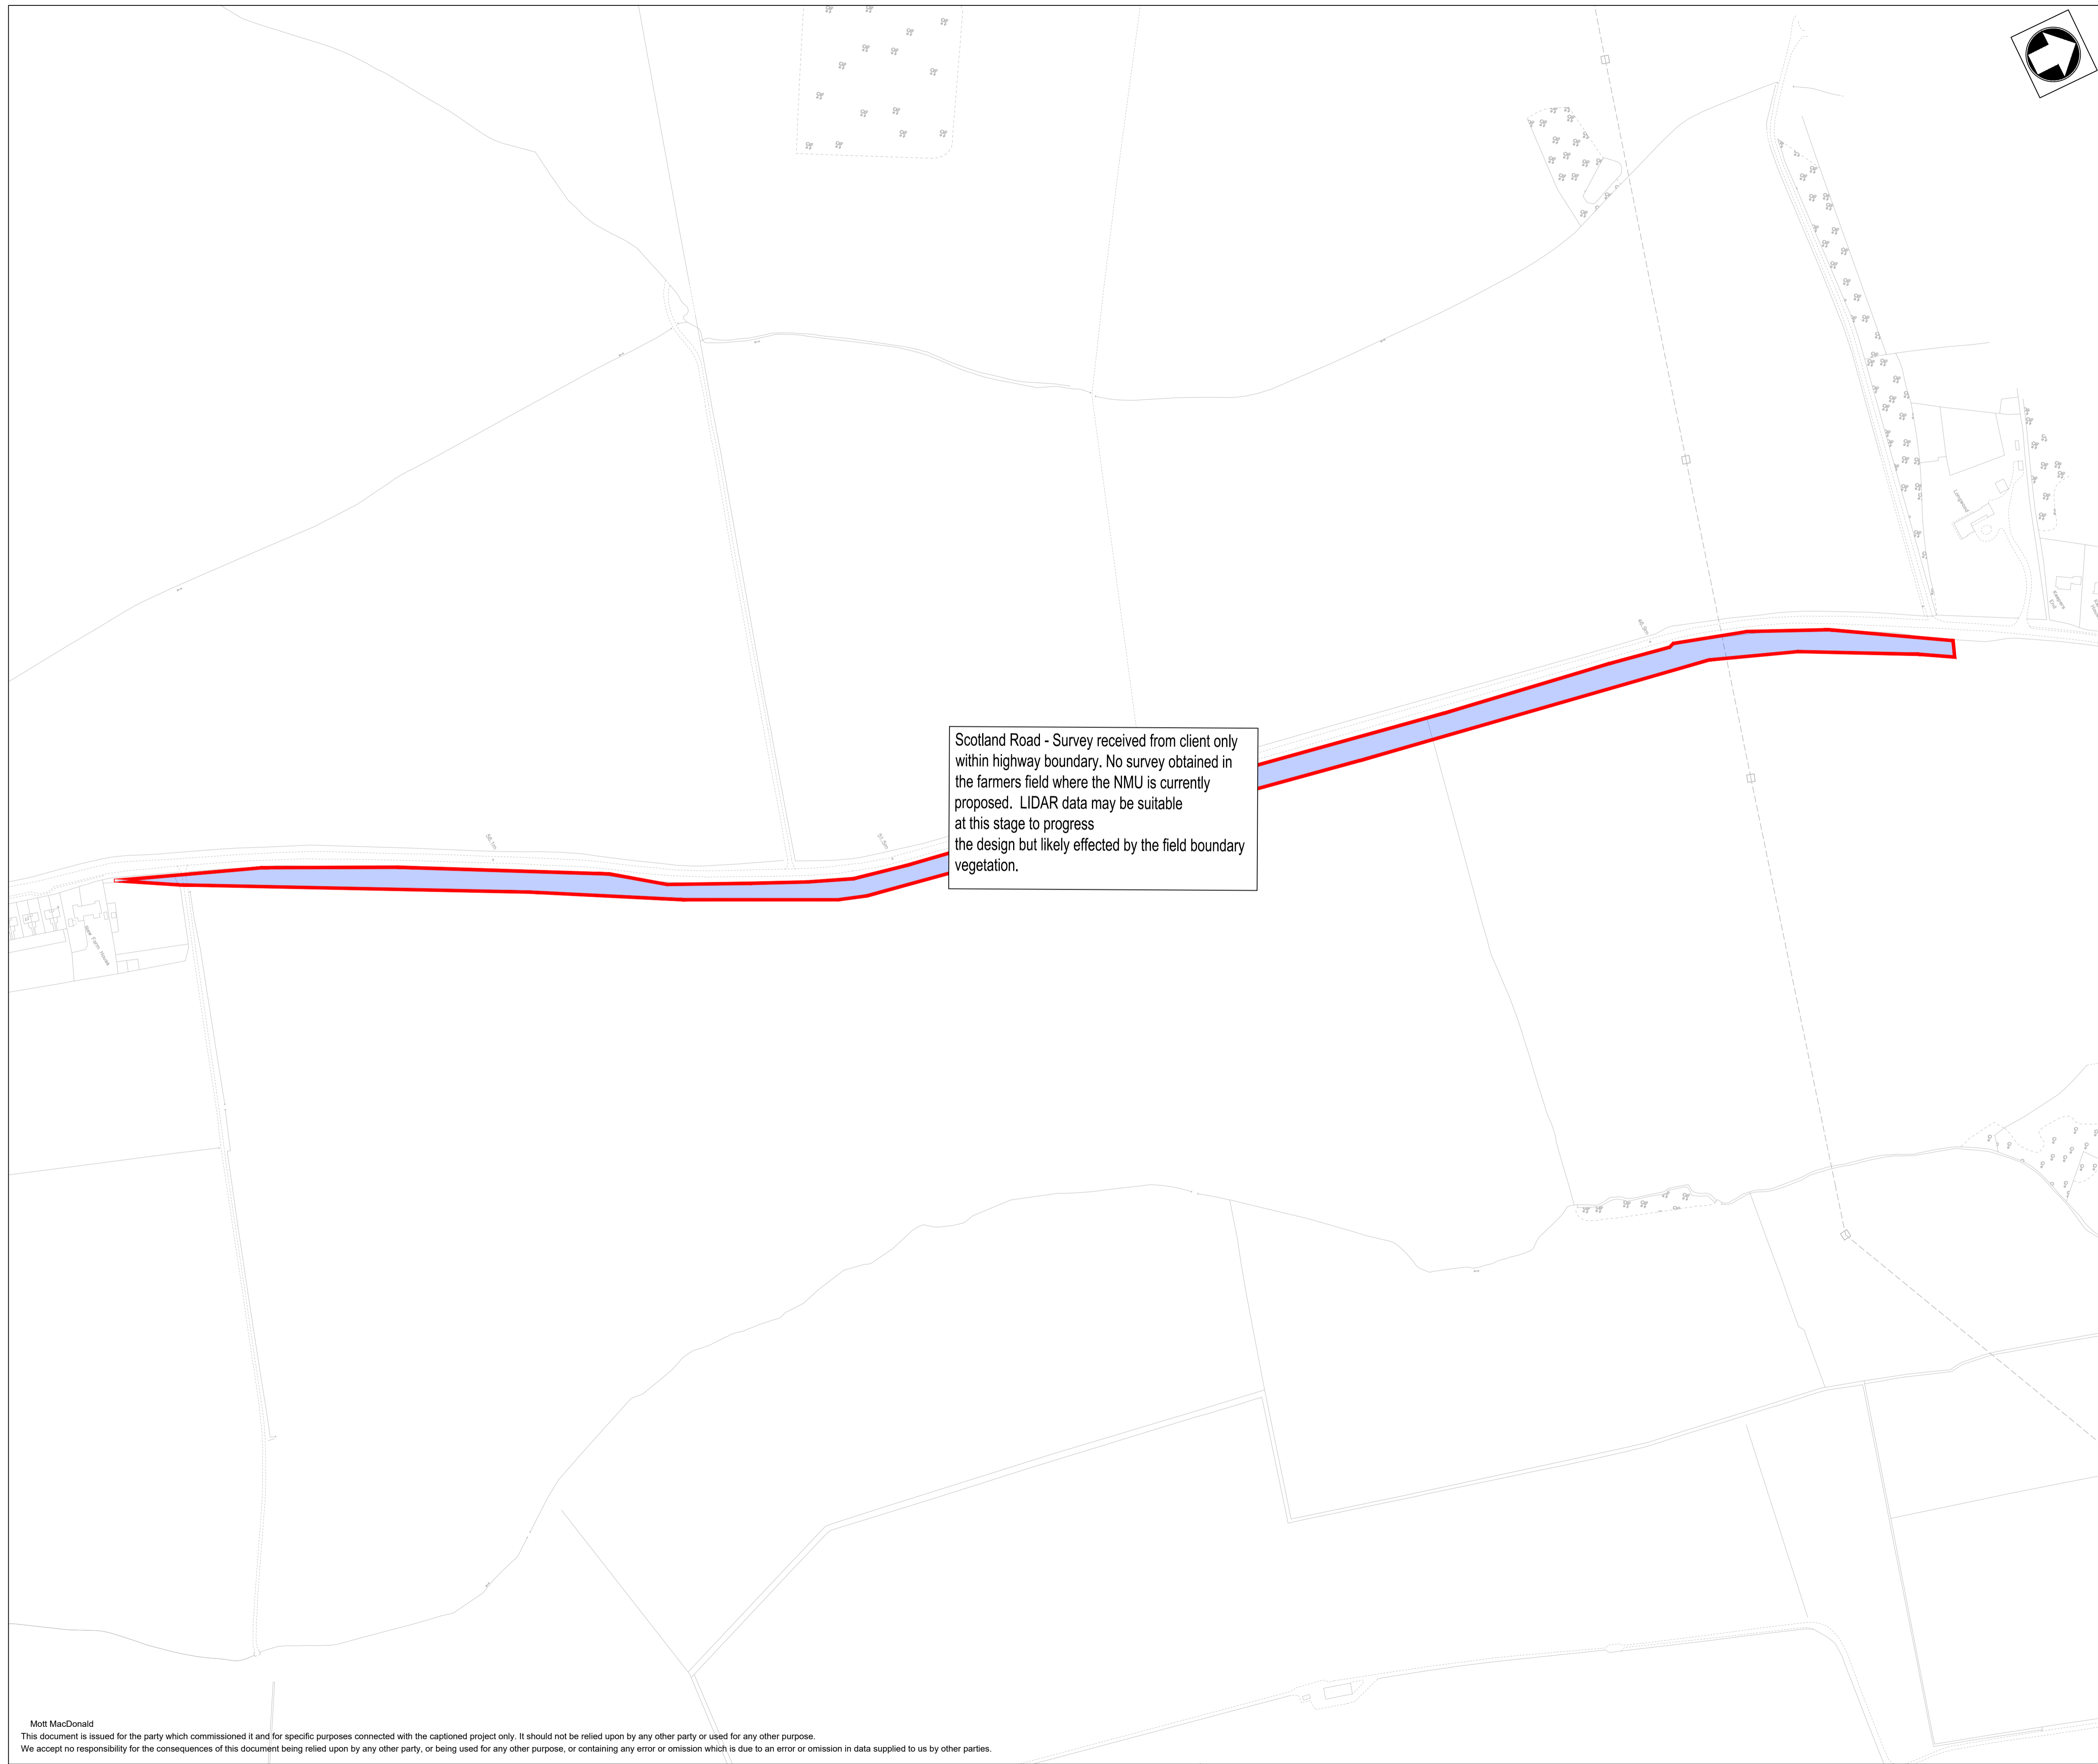
Drawing Number
392438-MMD-XX-C-SK-0020

Scotland Road - Survey received from client only within highway boundary. No survey obtained in the farmers field where the NMU is currently proposed. LIDAR data may be suitable at this stage to progress the design but likely effected by the field boundary vegetation.

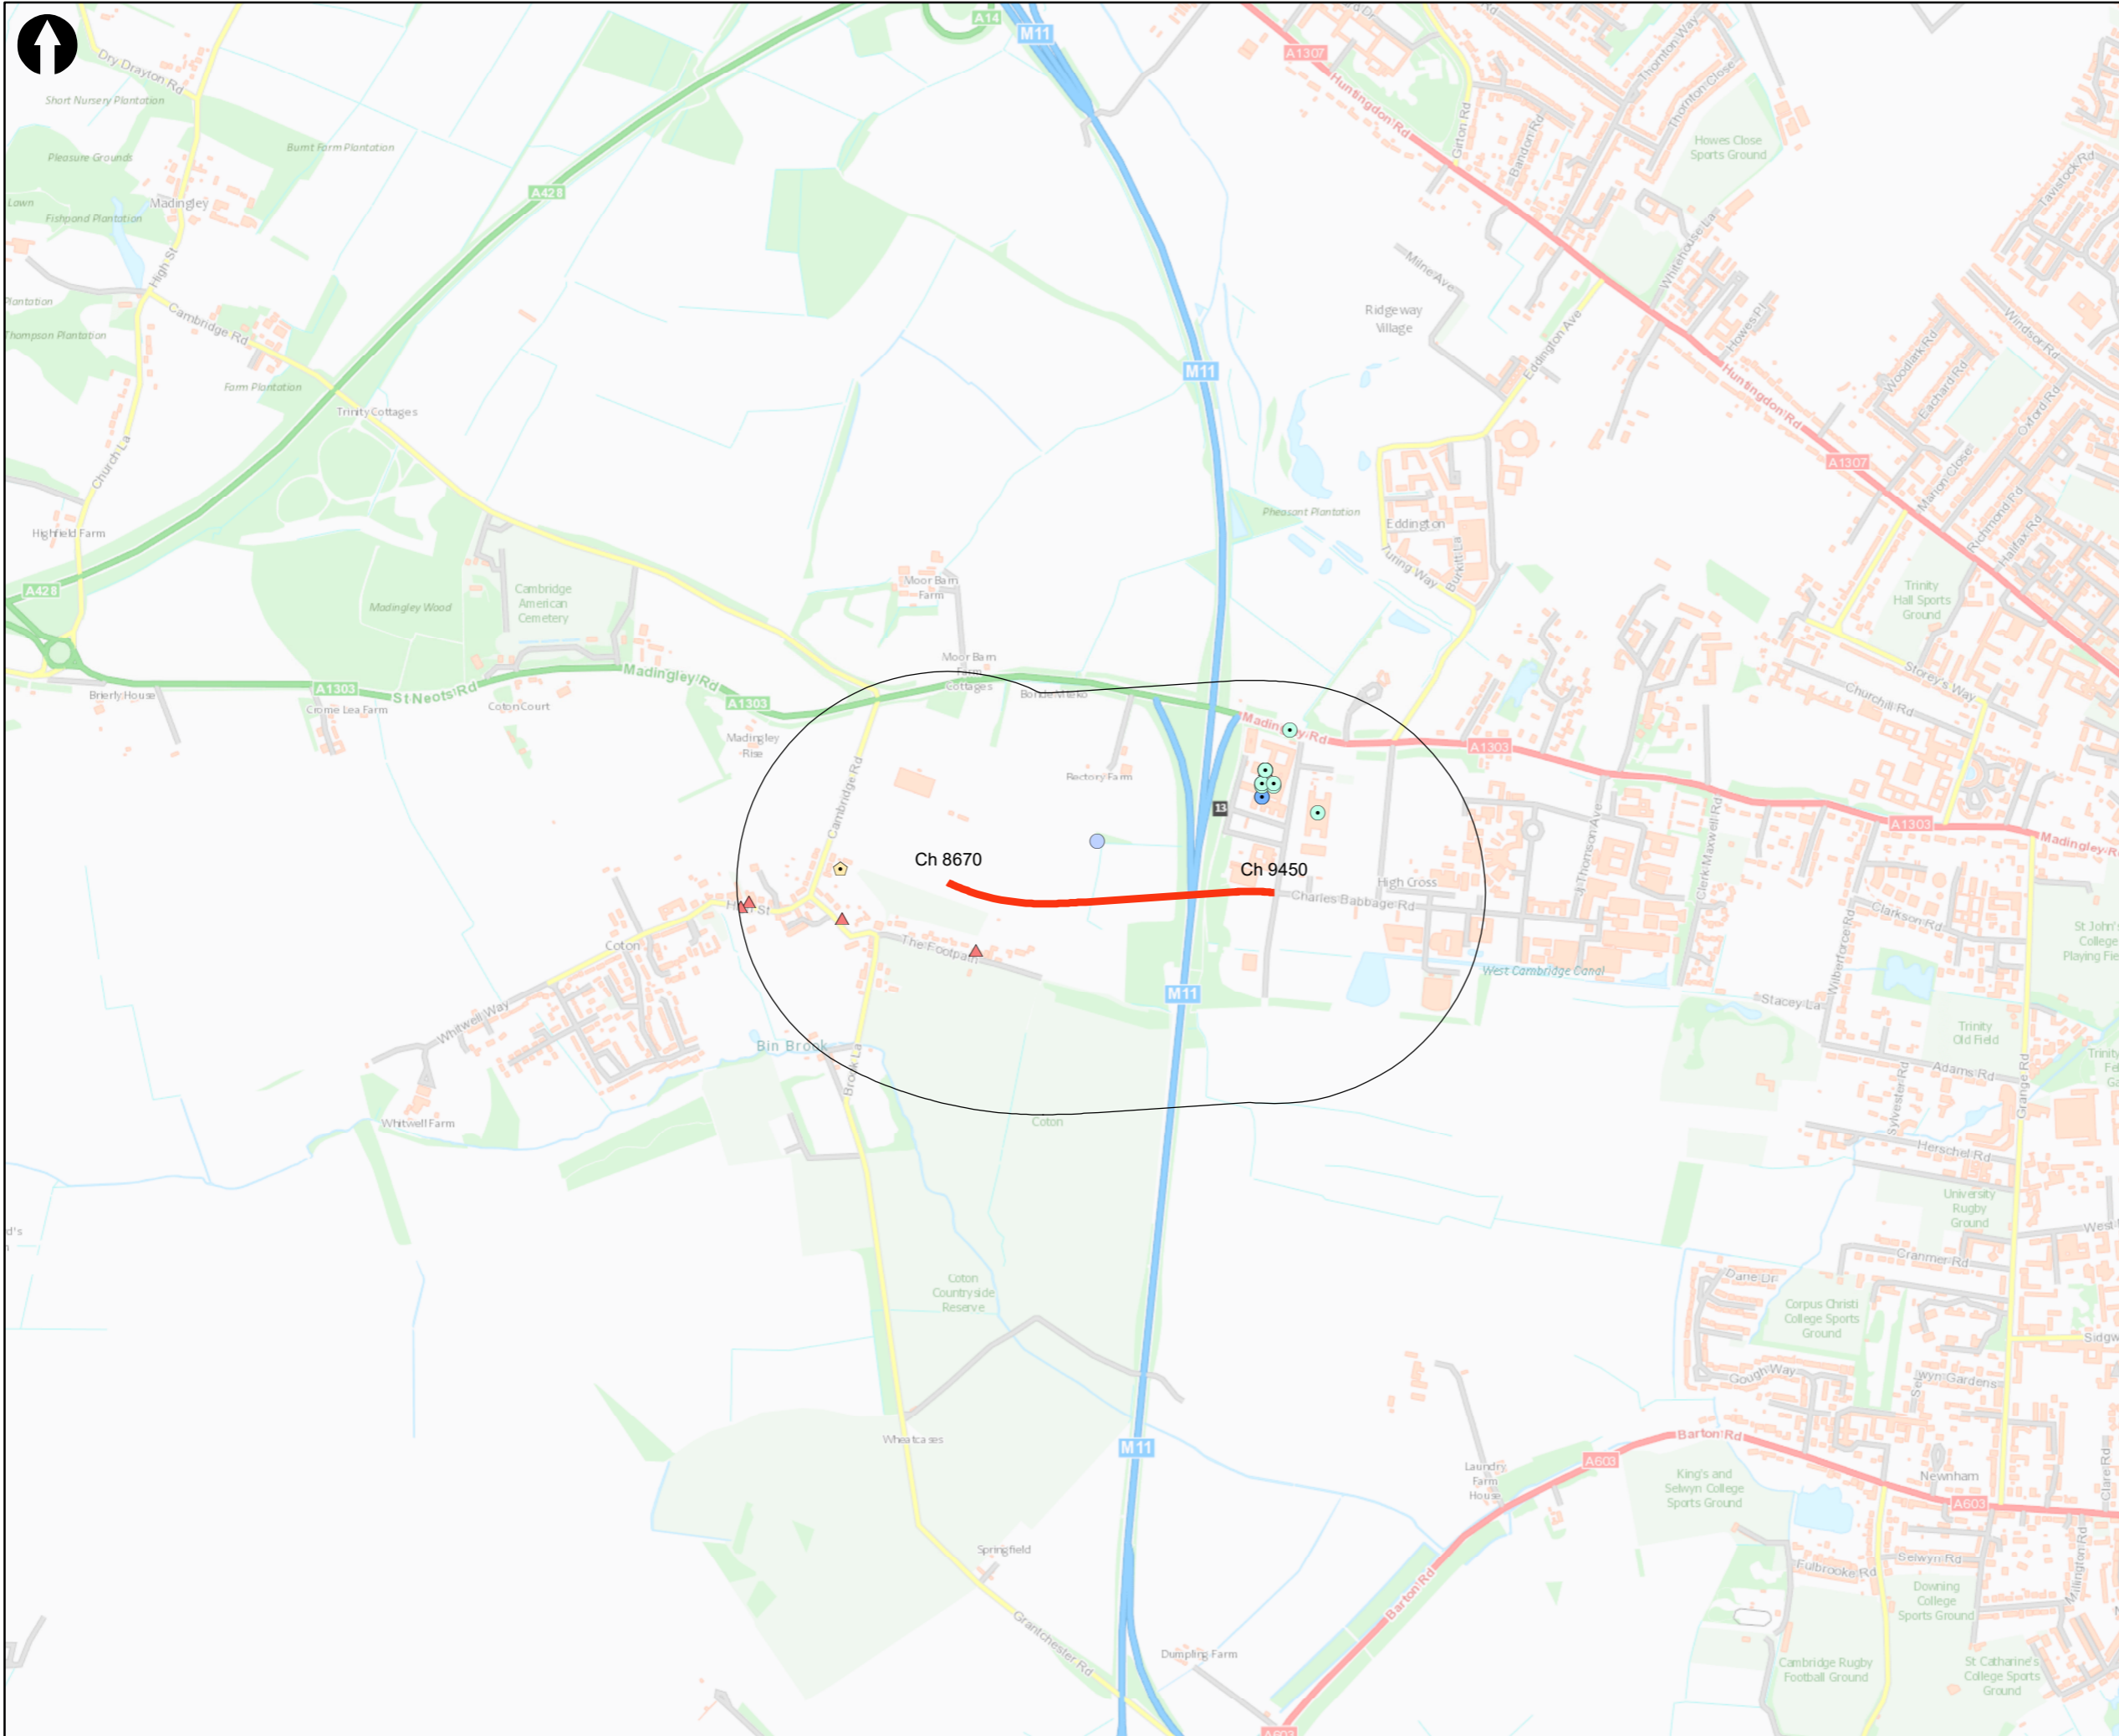
Drawing Number
 392438-MMD-GIS-XX-DR-GEO-0005

Title
 Cambourne to Cambridge
 Geotechnical and Geo-environmental
 Preliminary Risk Assessment
 Route Zone 5
 Environmental Constraints Plan

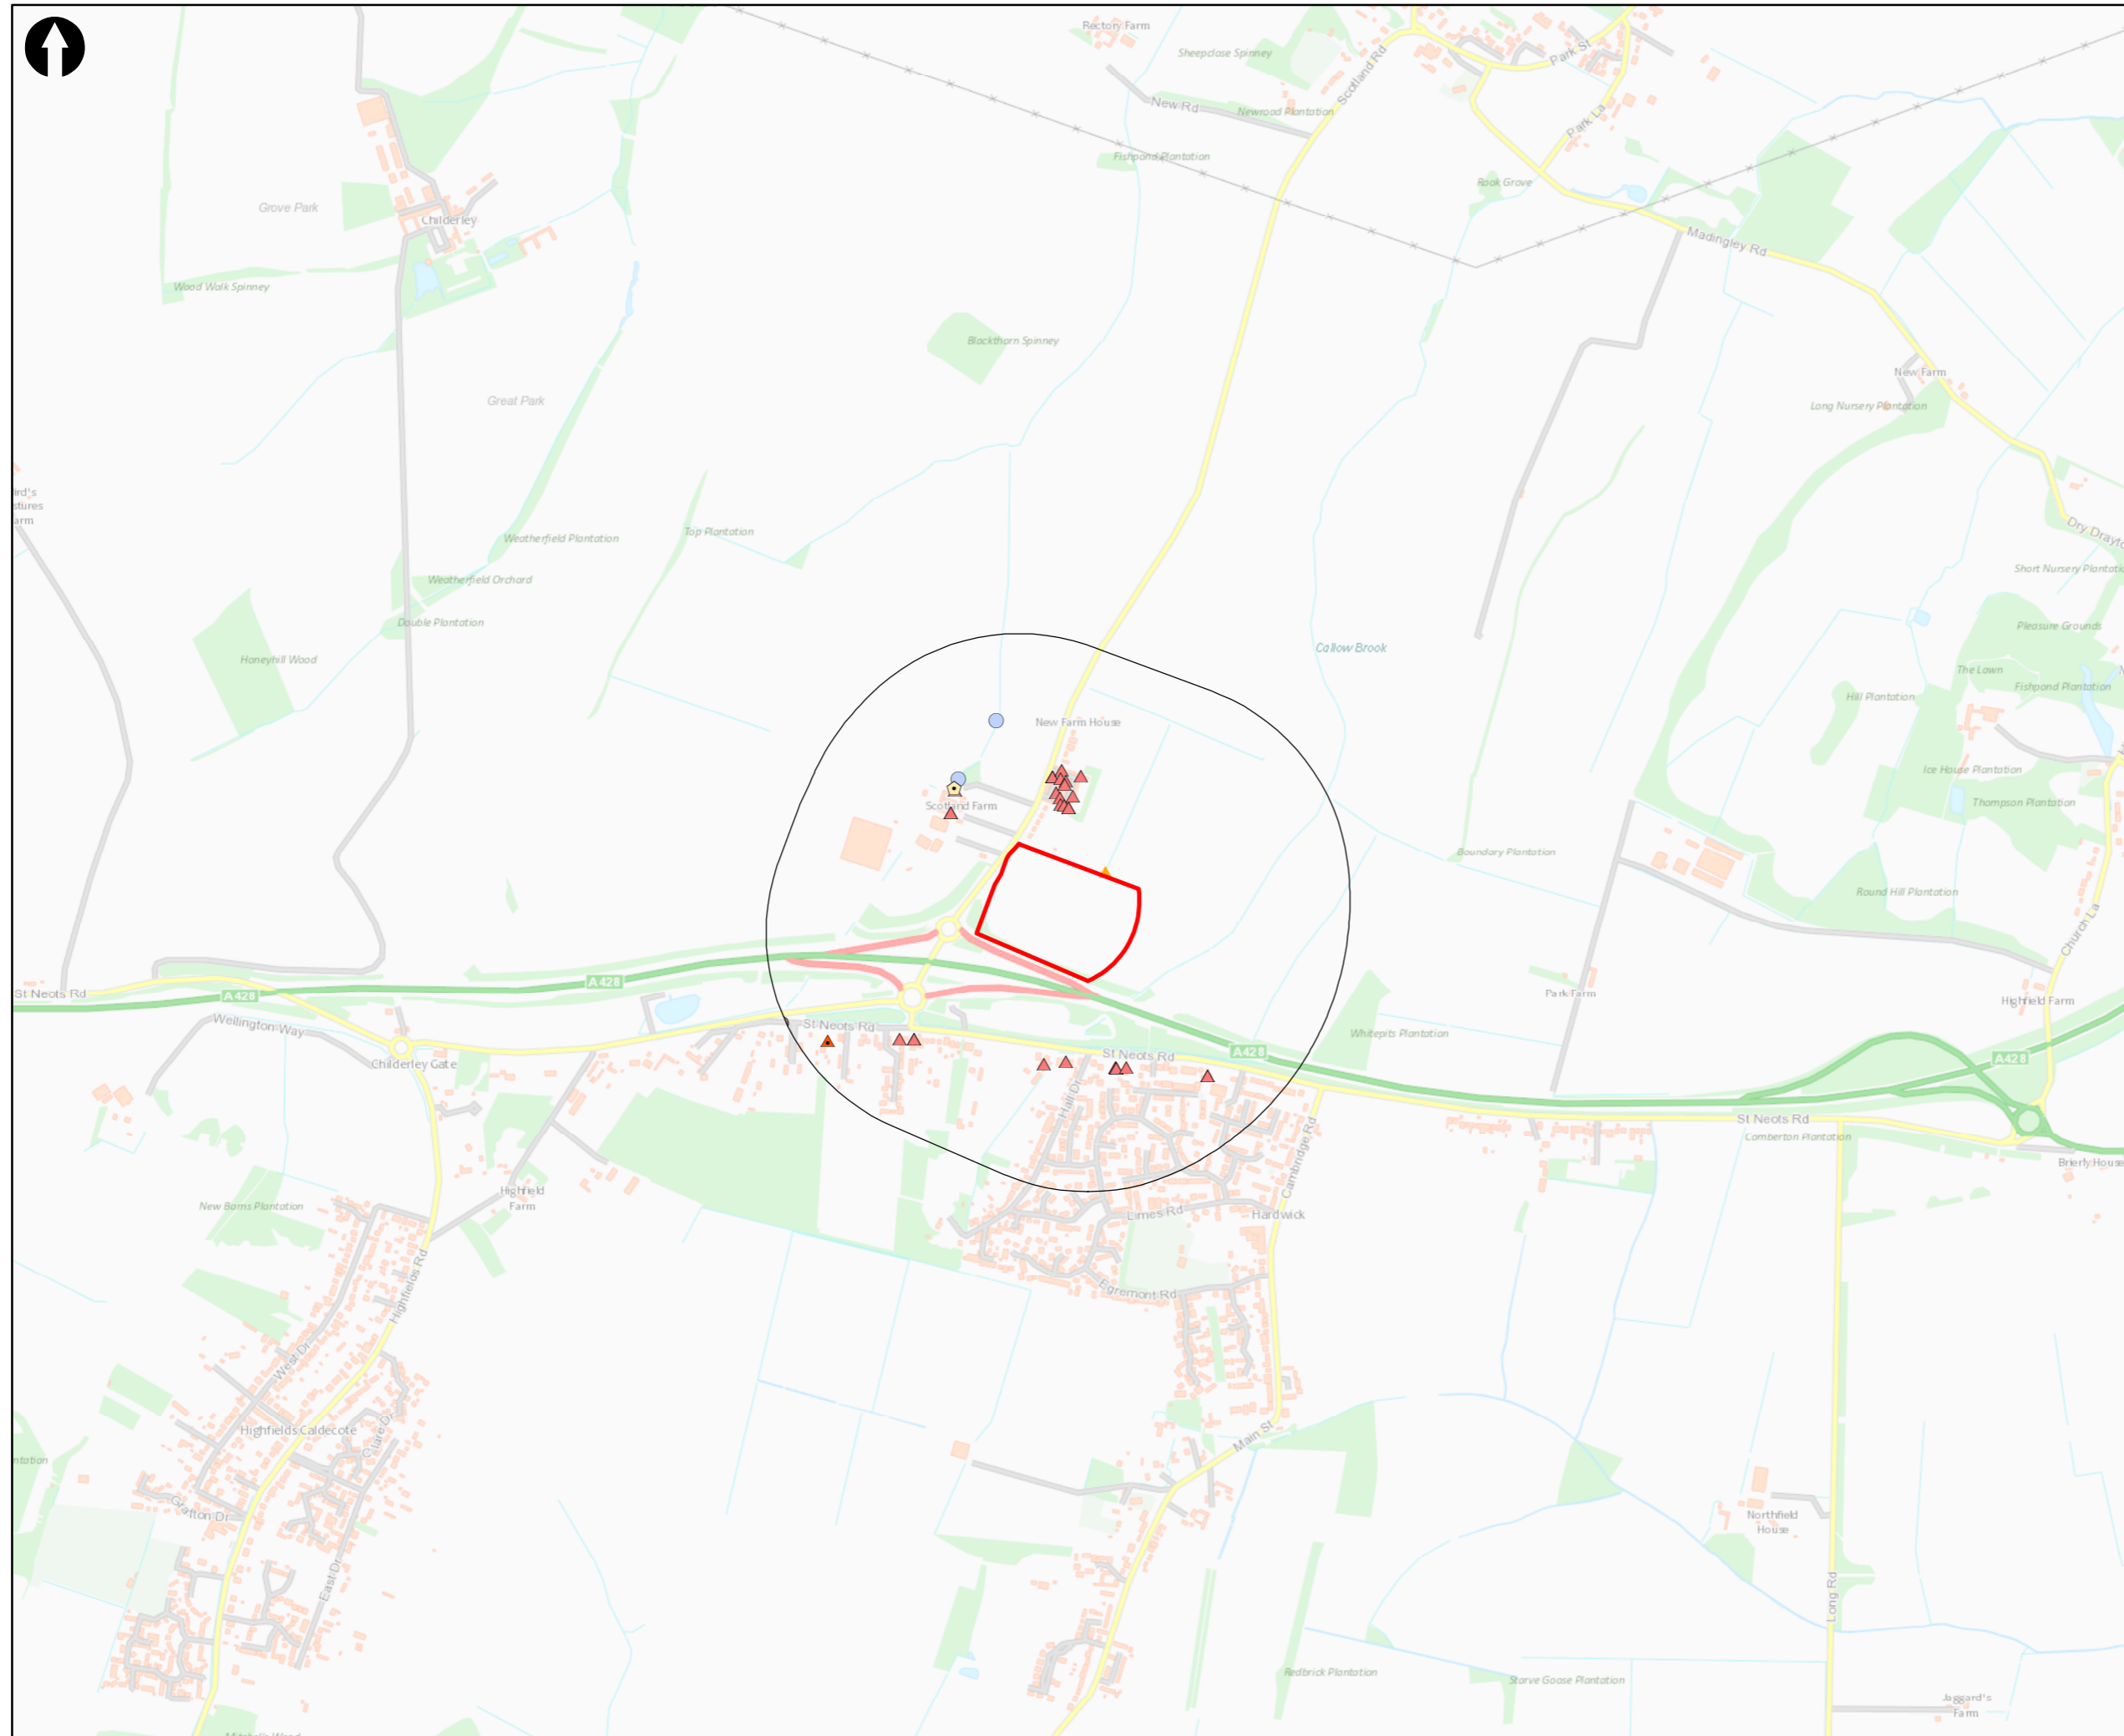
Drawing Number
392438-MMD-GIS-XX-DR-GEO-0007

Camborne to Cambridge
Geotechnical and Geo-environmental
Preliminary Risk Assessment
Route Zone 7
Environmental Constraints Plan
