CAMBOURNE TO CAMBRIDGE

Environmental Statement

Desk Study for Potential Unexploded Ordnance Contamination

Bourn Airfield

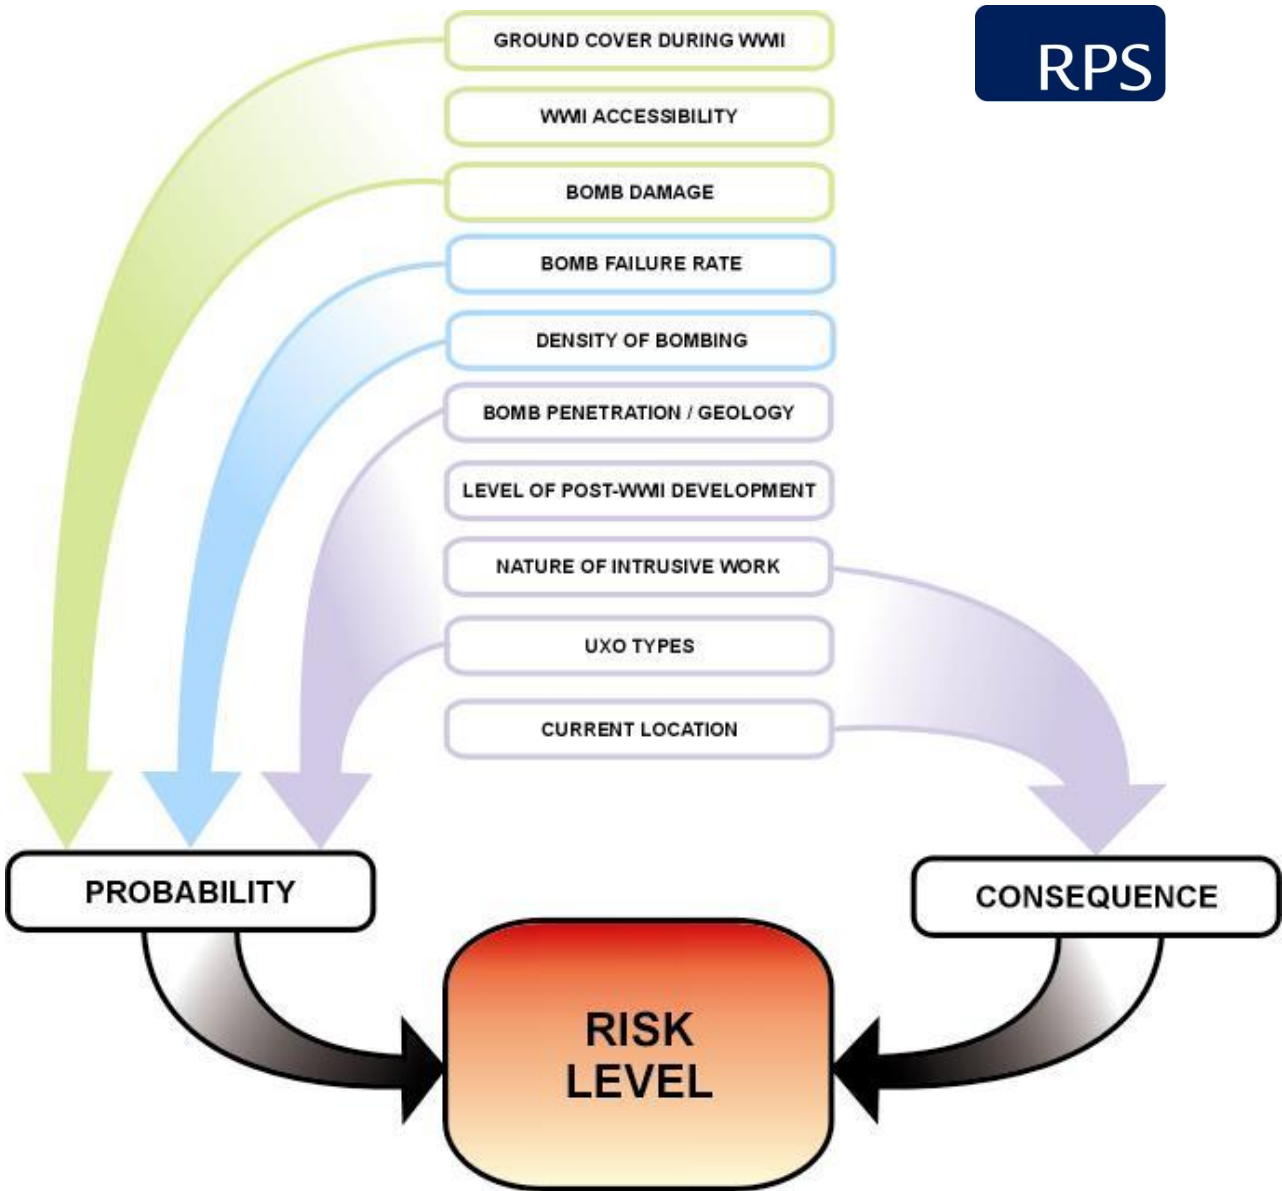
The following sections contain the risk assessment for the site, prior to the implementation of any risk mitigation measures. For the risk to be properly defined, several factors have to be taken into account, including the consequences of initiation and the probability of encountering UXO on site. The technique used to assess level of risk is detailed in the diagram below:

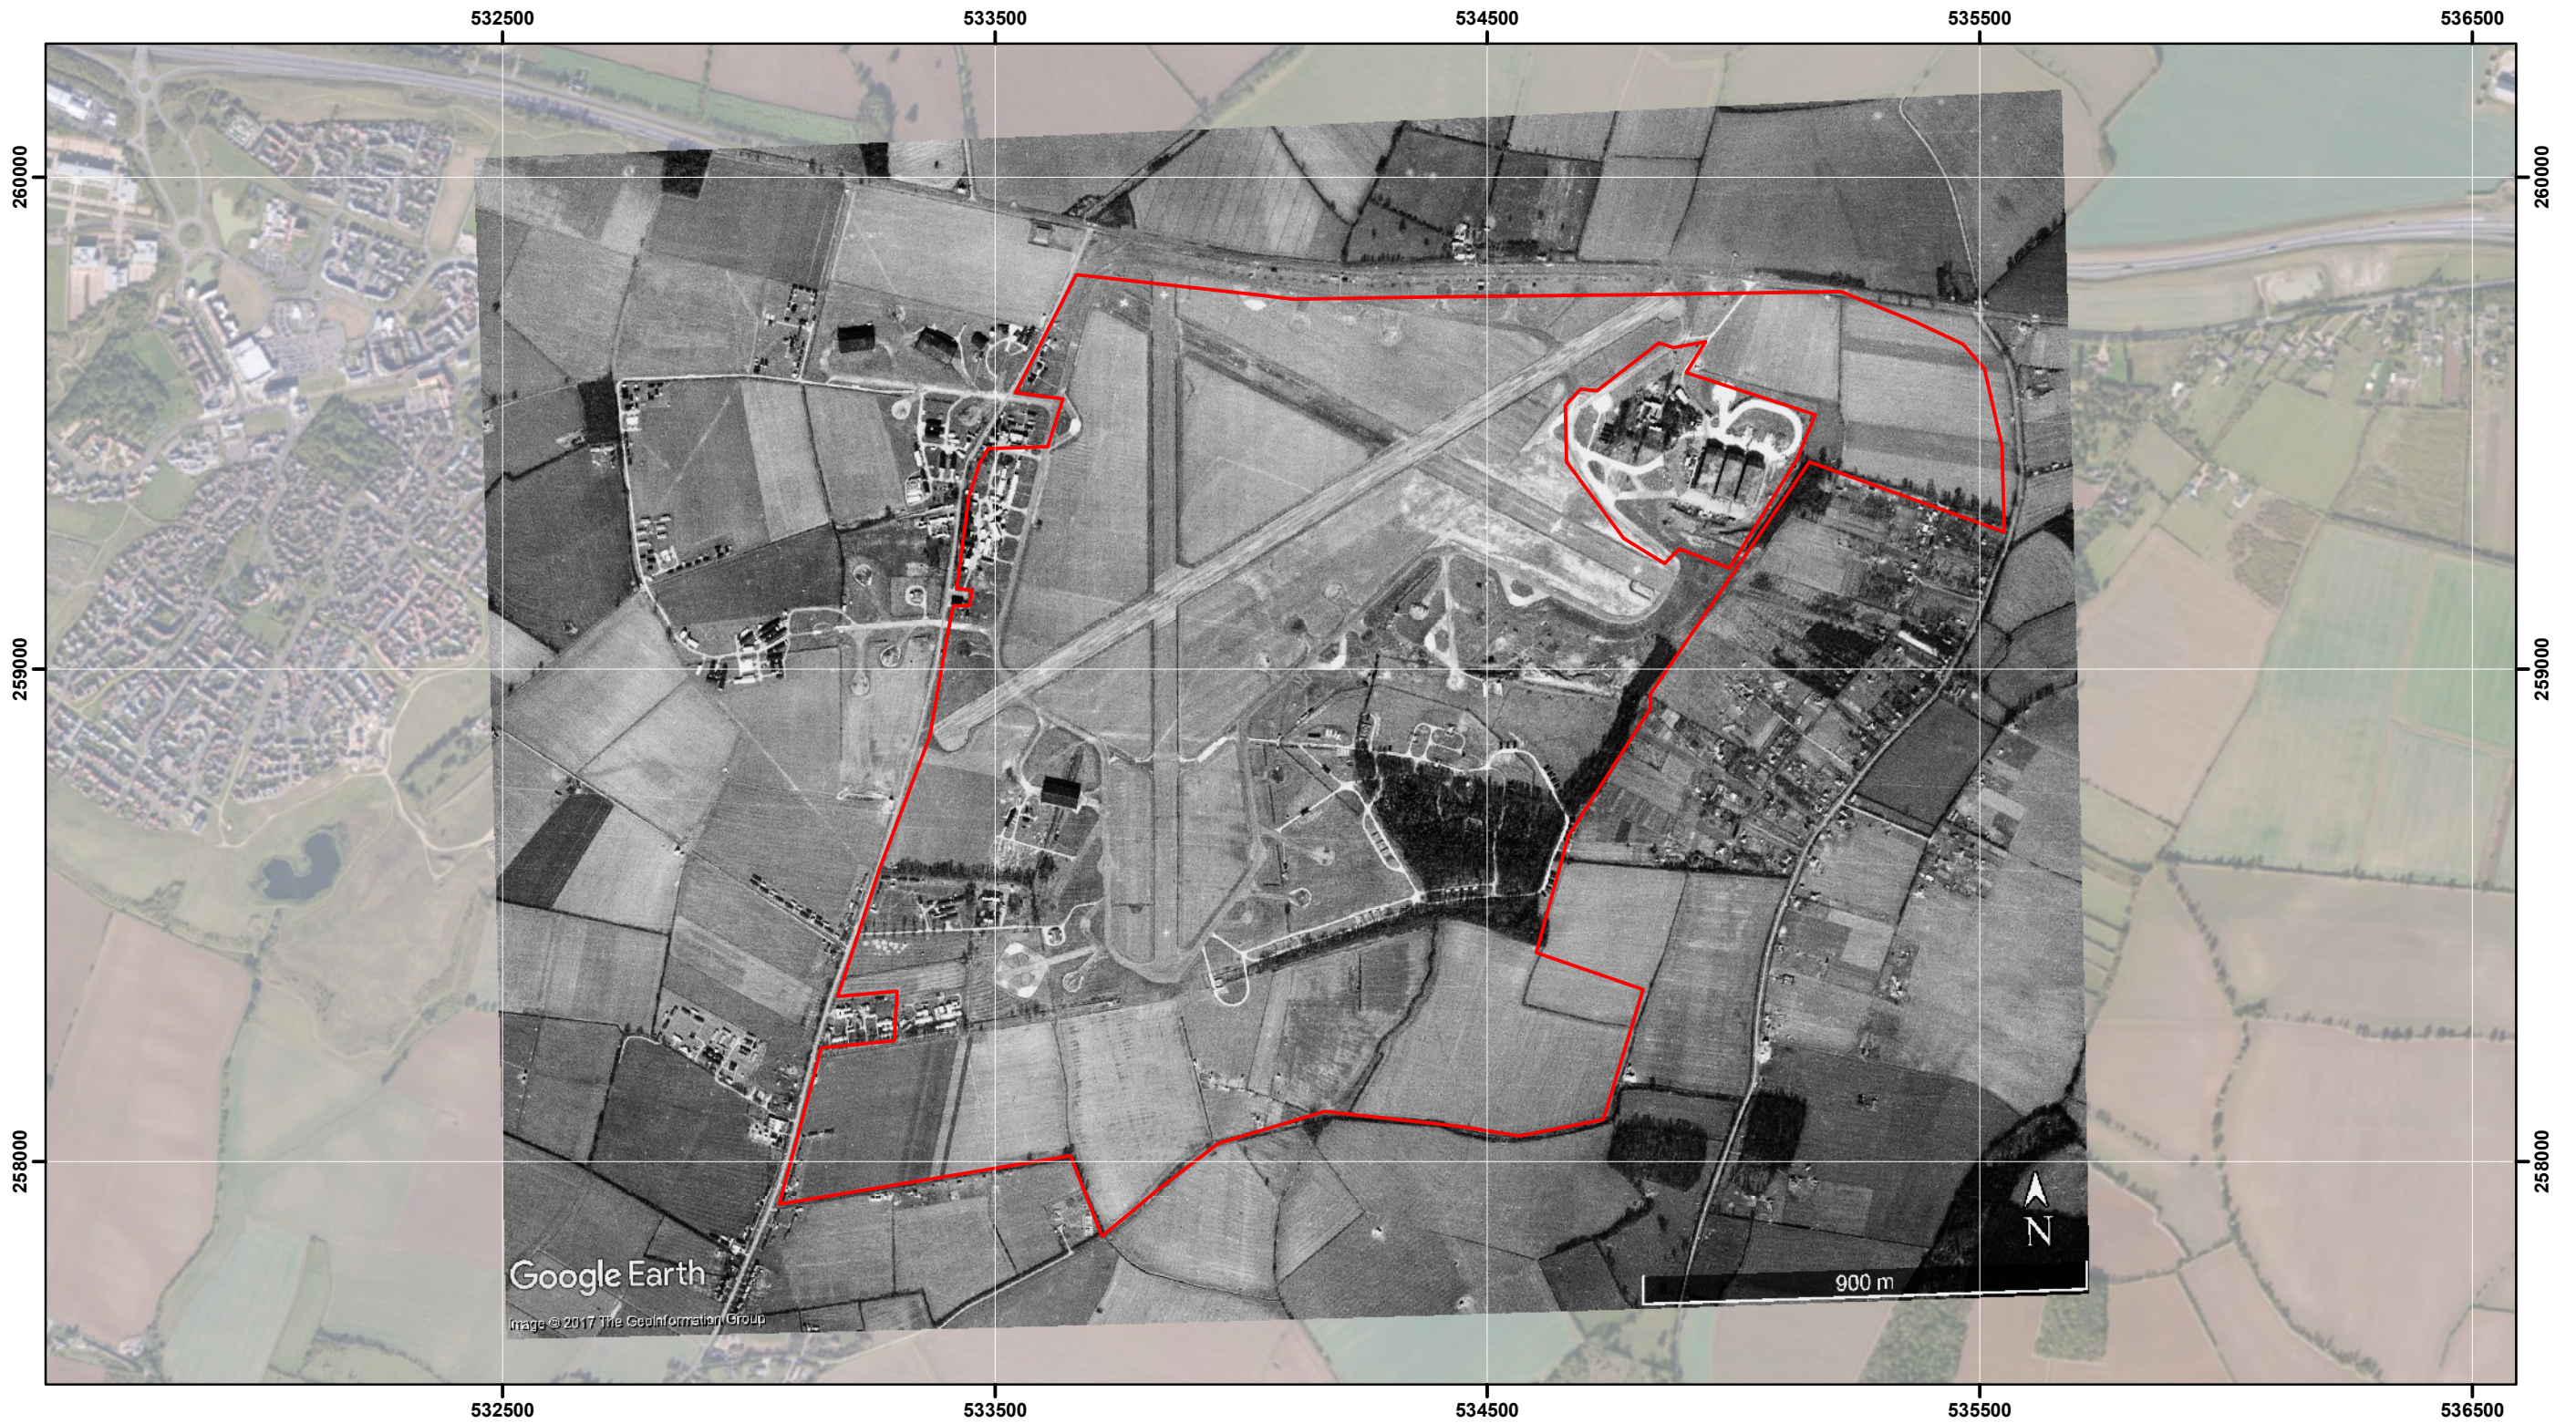
1945 Bourn Aerial Image

RPS EES has reviewed aerial imagery from 1945 that covers the site. This imagery clearly shows the airfield in situ although no aircraft are apparent. Several outbuildings are present across the site with no apparent damage visible. Areas of worked fields and wooded land are present within the bounds of the site in the imagery. The image has been presented at *Appendix 005*.

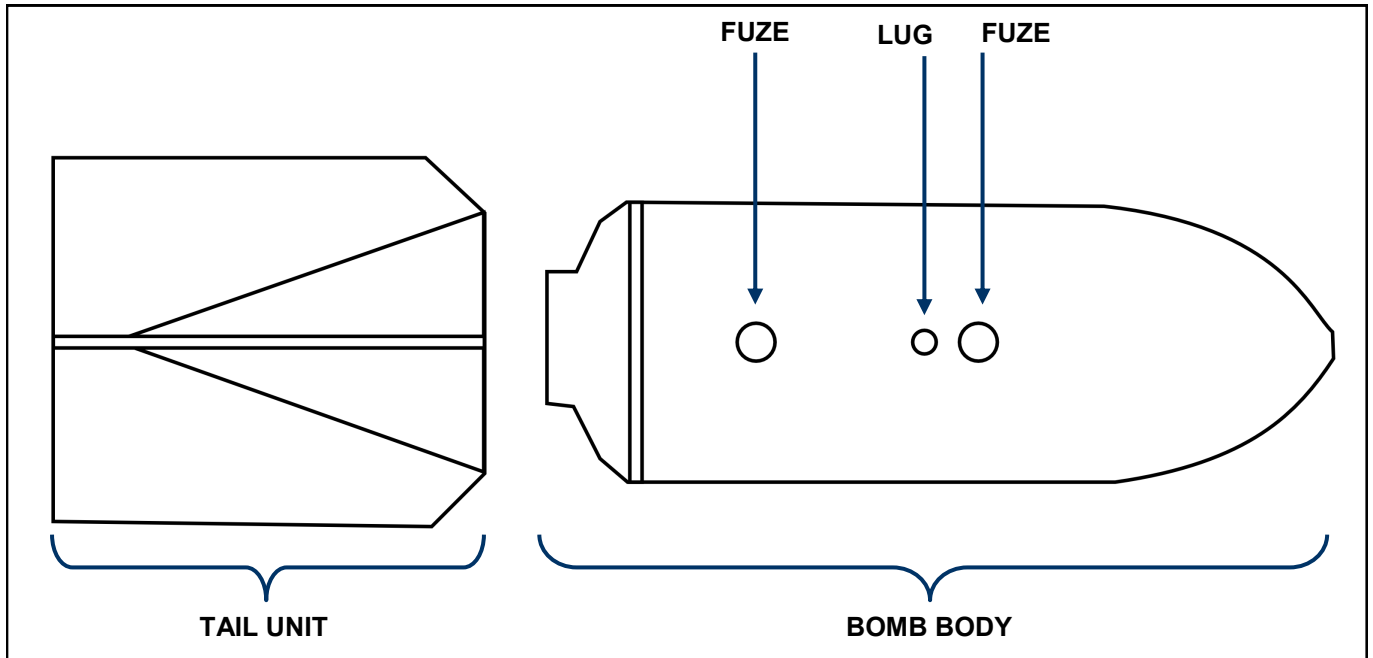
TYPICAL WWII GERMAN AERIAL DELIVERED BOMB COMPONENTS

The main components of a bomb are:

- **Bomb Body** – This is the main item referred to as an Unexploded Bomb (UXB). The General Purpose bombs will have a typical bomb shape with parallel sides. Given the age and environmental conditions most bombs are found corroded. It is possible to mistake them for old gas cylinders or boiler tanks.
- **Tail Unit** – As the UXB enters the ground this section is removed. The presence of a tail unit may indicate that an UXB is buried at depth in the region.
- **Fuze** – With a German UXB it is most likely that the bomb would have a mechanical or electrical transverse fuse. In some case a bomb may contain two fuses. On a German UXB the fuzes were of an alloy construction and therefore a visual contrast from the bomb body.

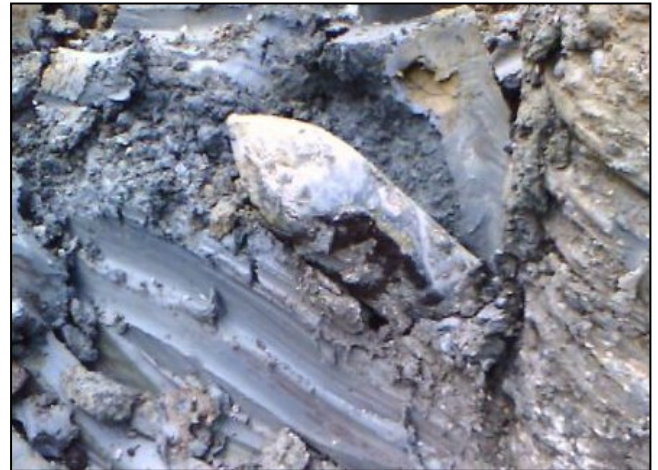
50kg SC HE Bomb discovered by RPS on a construction site in London (2006)

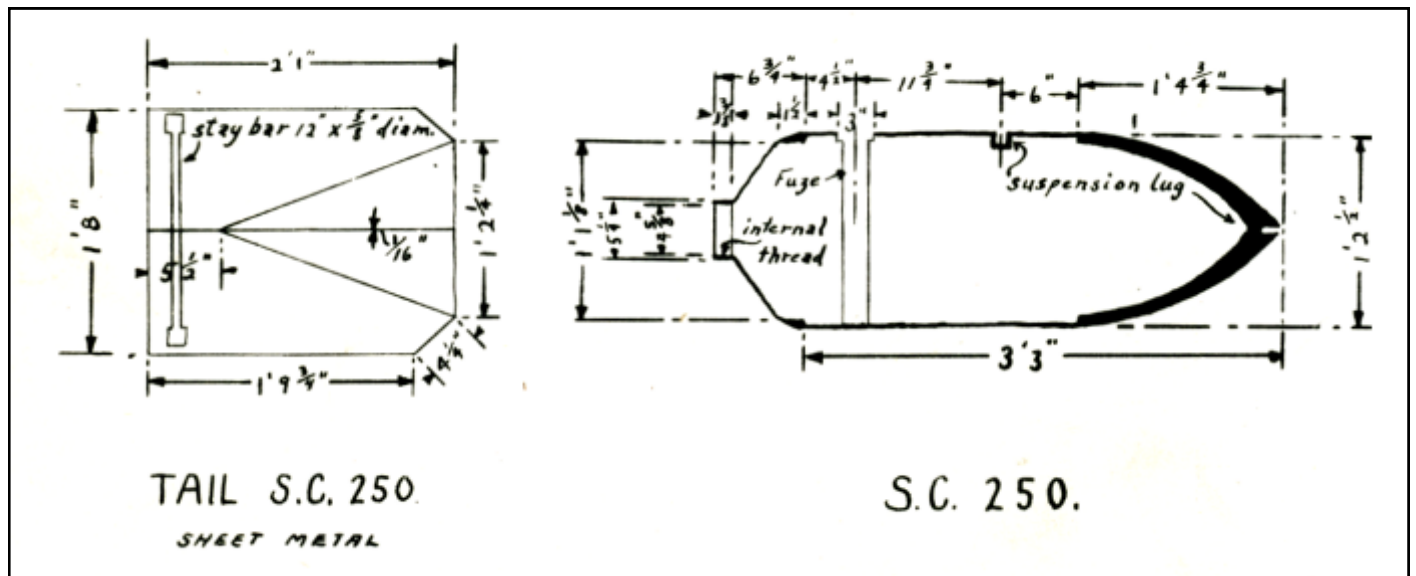
250kg SC High Explosive Bomb Schematics

SC250 Data

Bomb Body Weight = 245-256kg

Fuze = Any (Commonly Type 7 Time Fuze)

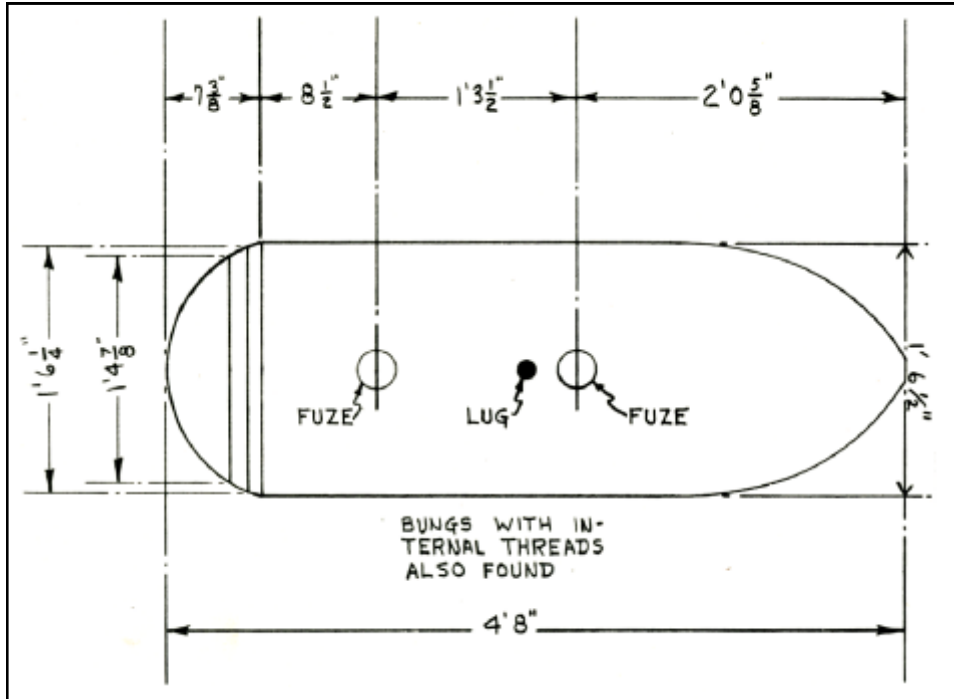
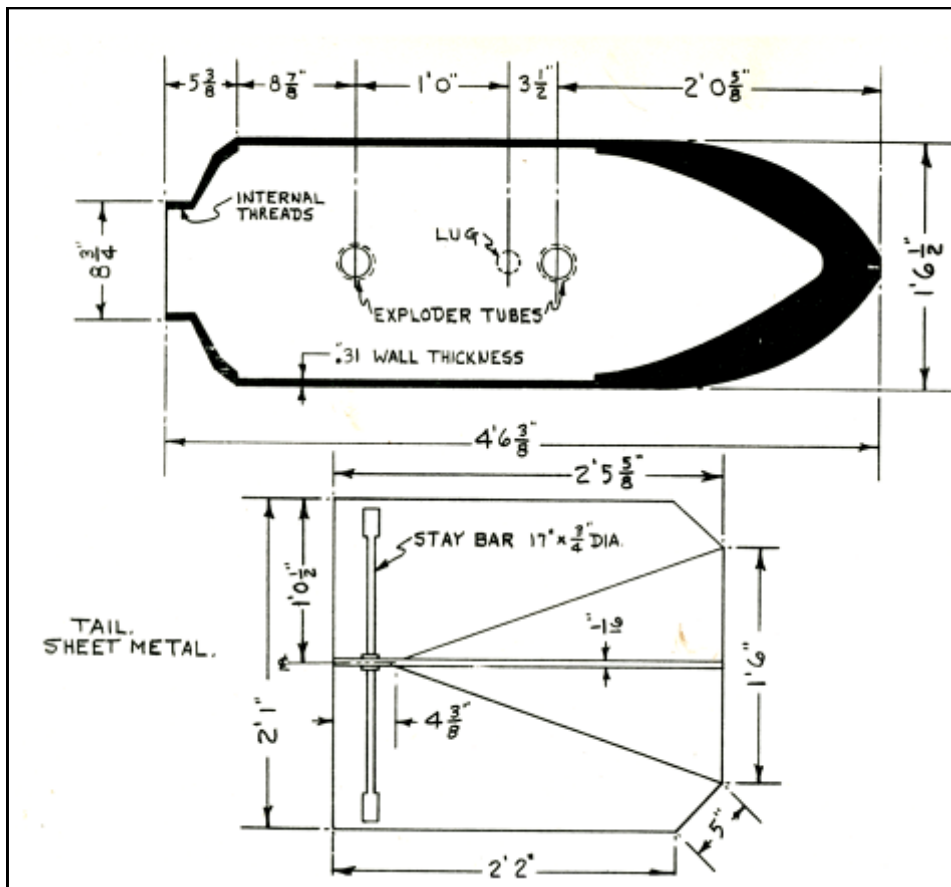
500kg SC High Explosive Bomb Schematics

SC500 Data

Bomb Body Weight = 480-520kg

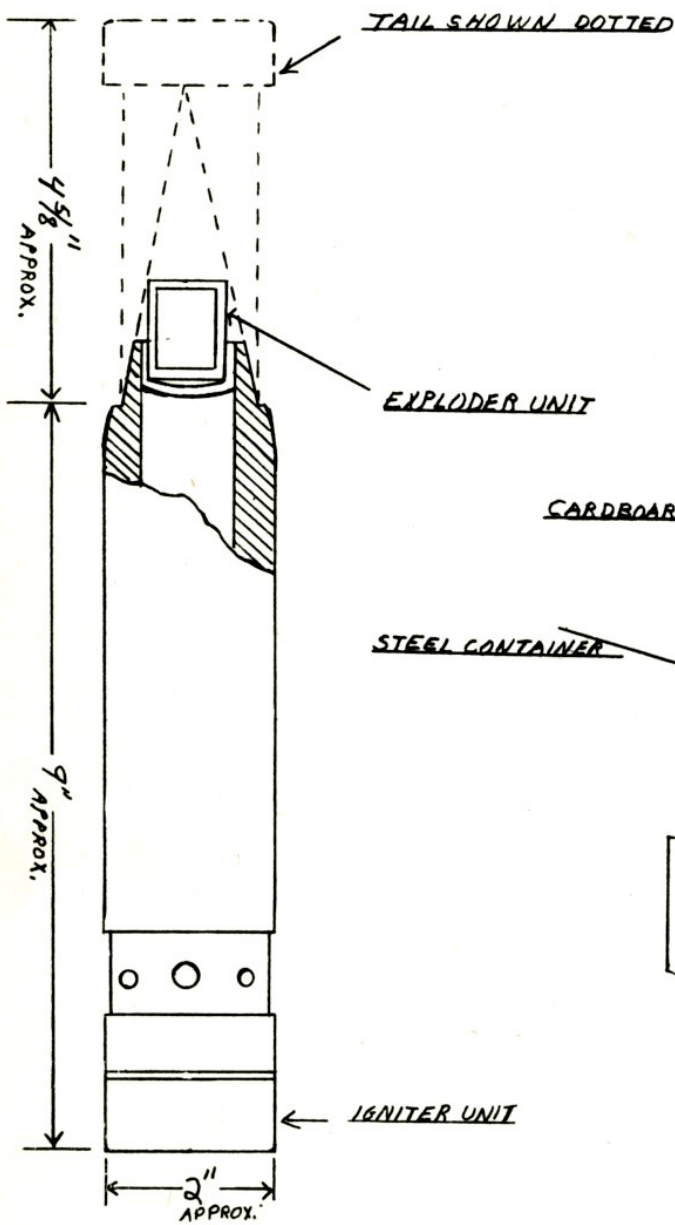
B-1 & B-1.3 E Data

Bomb Body Weight = 1kg

Fill = 680g (1.3lb) Thermit

Fuze = Impact

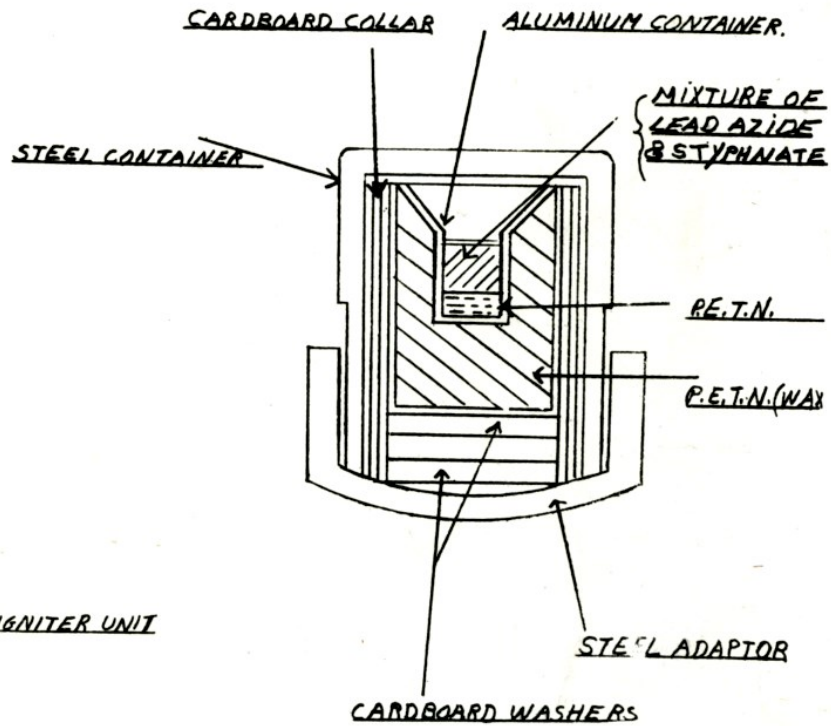
B-1 1kg Incendiary Bomblet

By 1942, Oil Bombs had been superseded by a smaller and more intensely burning incendiary bomblet made of magnesium. These weighed only 1kg, so could be dropped in containers carrying hundreds of individual bomblets. Some were coupled with a small High Explosive charge that went off when the magnesium was alight to spread the fire over a wider area. A corroded 1kg incendiary bomb can closely resemble a short section of scaffold tube.

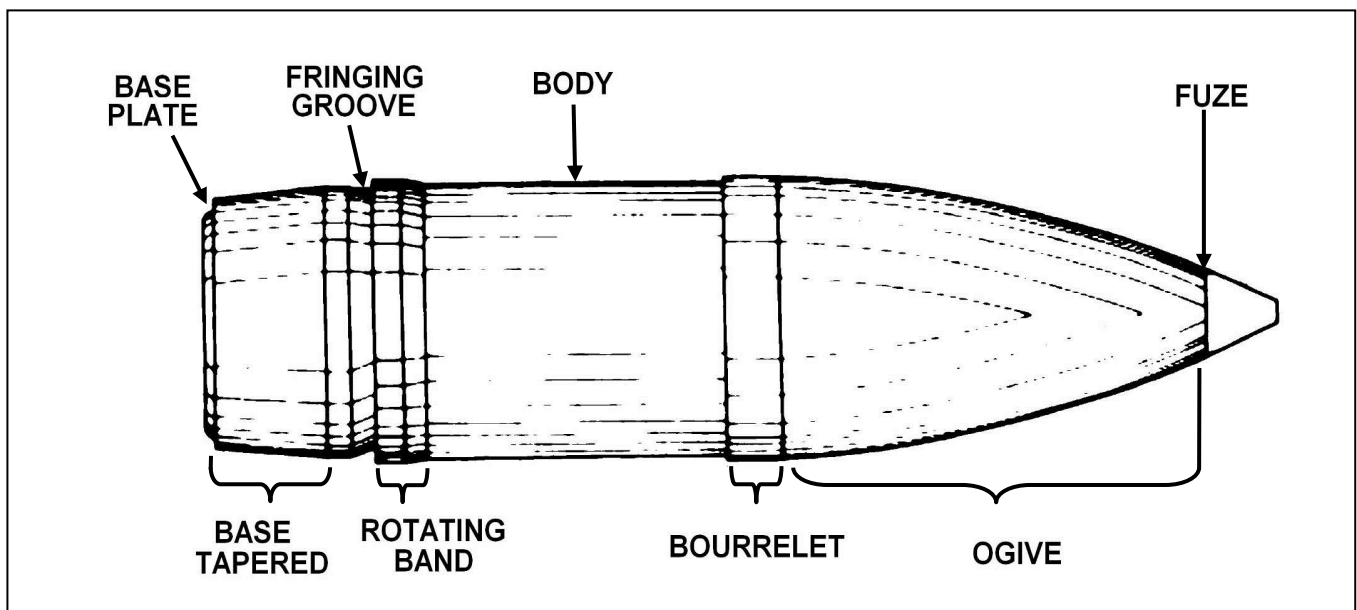
TYPICAL PROJECTILE COMPONENTS

- **Fuze** – The part of the device which initiates the detonation of the payload. Usually artillery munitions have nose fuzes, although some do have base fuzes. When used with HE shells, 'airburst' fuzes usually have a combined airburst and impact function.
- **Projectile** – This is the part of the munition that generally contains the main payload, and will be ejected from the main munition during firing. Artillery shell projectiles can range between bursting, base ejection or nose ejection.
- **Propellant** – Propellant in artillery munitions is always low explosive.
- **Primer** – The primers purpose is to initiate the propellant upon firing.

In most cases, the part of the munition that is likely to remain as UXO, as a result of malfunction during firing, is the Projectile (potentially with fuze), as this is the part of the device that is fired through the air.

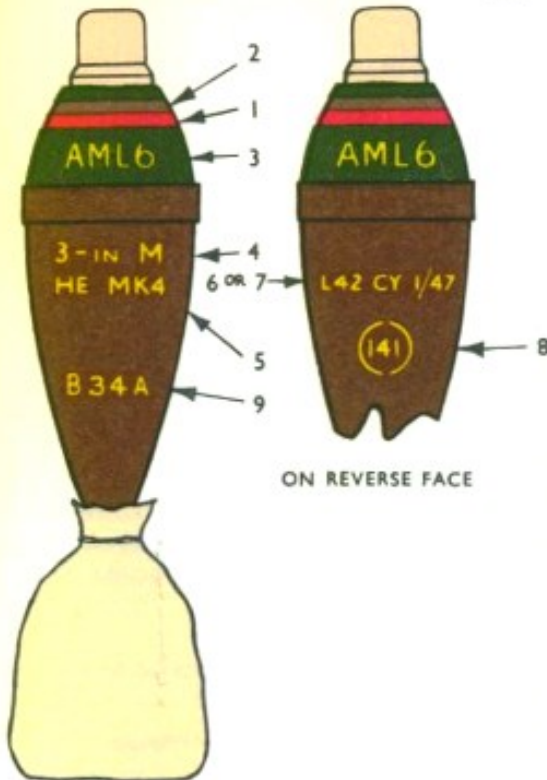
FIG.1

HE

AREAS SHOWN DARK BROWN INDICATES BODY PHOSPHATED AND VARNISHED

- 1 RED FILLING RING
- 2 BROWN RING (DENOTING CAST IRON)
- 3 CODE DENOTING NATURE OF FILLING
- 4 CALIBRE AND NATURE OF WEAPON
- 5 TYPE AND MARK, OR MODEL NUMBER, OF BOMB
- 6 ONE LINE CODE (METHOD OF FILLING) FOR BOMBS WITH MARK NUMBER
- 7 INITIALS OR RECOGNIZED MONOGRAM OF FILLER AND DATE OF FILLING (FOR BOMBS WITH MODEL NUMBER)
- 8 FILLED SERIES NUMBER
- 9 BATCH NUMBER, WHEN BOMBS ARE ISSUED FUZED AND CARTRIDGED

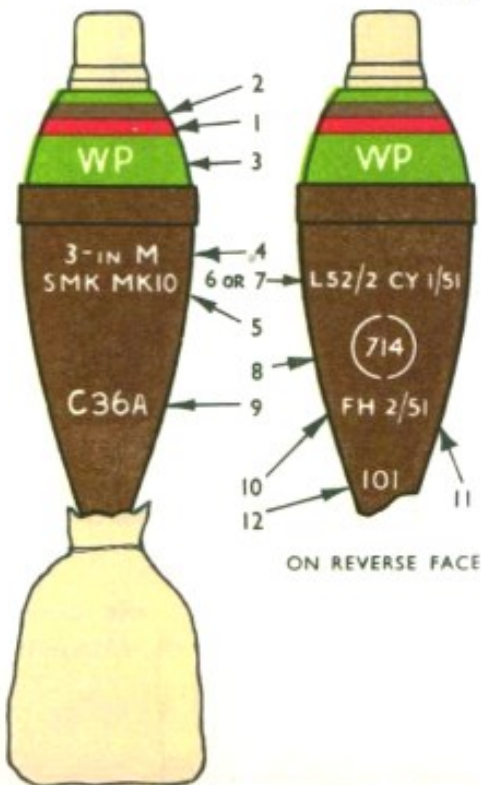
FIG.2

SMOKE BURSTING

AREAS SHOWN DARK BROWN INDICATES BODY PHOSPHATED AND VARNISHED

- 1 RED FILLING RING
- 2 BROWN RING (DENOTING CAST IRON)
- 3 CODE DENOTING NATURE OF FILLING
- 4 CALIBRE AND NATURE OF WEAPON
- 5 TYPE AND MARK, OR MODEL NUMBER, OF BOMB
- 6 ONE LINE CODE (METHOD OF FILLING) FOR BOMBS WITH MARK NUMBER
- 7 INITIALS OR RECOGNIZED MONOGRAM OF FILLER AND DATE OF FILLING (FOR BOMBS WITH MODEL NUMBER)
- 8 FILLED SERIES NUMBER
- 9 BATCH NUMBER, WHEN BOMBS ARE ISSUED FUZED AND CARTRIDGED
- 10 RECOGNIZED MONOGRAM OR INITIALS OF CHARGING STATION
- 11 DATE OF CHARGING (MONTH & YEAR)
- 12 CHARGING LOT NUMBER

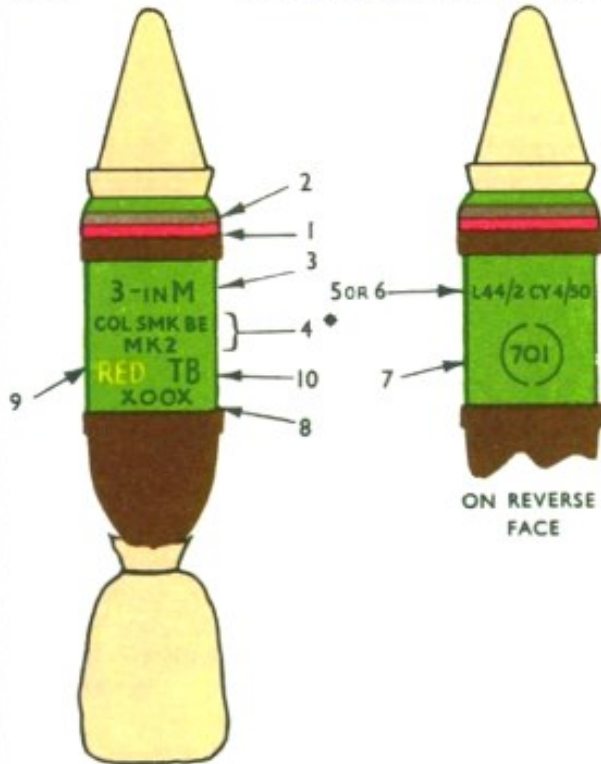
FIG.1

COLOURED SMOKE BE AND COLOURED SMOKE SKYTRAIL

AREAS SHOWN DARK BROWN INDICATES BODY PHOSPHATED AND VARNISHED

- 1 RED FILLING RING
- 2 BROWN RING (DENOTING CAST IRON)
- 3 CALIBRE AND NATURE OF WEAPON
- 4 TYPE AND MARK, OR MODEL NUMBER, OF BOMB
* (SMK TRAIL BE MK 2 FOR SKYTRAIL)
- 5 ONE LINE CODE (METHOD OF FILLING) FOR BOMBS WITH MARK NUMBER
- 6 INITIALS OR RECOGNIZED MONOGRAM OF FILLER AND DATE OF FILLING (FOR BOMBS WITH MODEL NUMBER)
- 7 FILLED SERIES NUMBER
- 8 BATCH NUMBER, WHEN BOMBS ARE ISSUED FUZED AND CARTRIDGED
- 9 COLOUR OF SMOKE (AS APPLICABLE)
- 10 CODE DENOTING NATURE OF FILLING

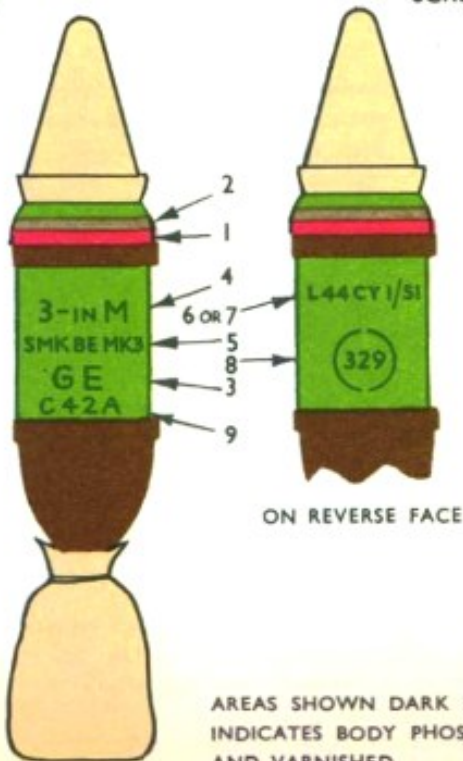
FIG.2

SCREENING SMOKE BE

- 1 RED FILLING RING
- 2 BROWN RING (DENOTING CAST IRON)
- 3 CODE DENOTING NATURE OF FILLING
- 4 CALIBRE AND NATURE OF WEAPON
- 5 TYPE AND MARK, OR MODEL NUMBER, OF BOMB
- 6 ONE LINE CODE (METHOD OF FILLING) FOR BOMBS WITH MARK NUMBER
- 7 INITIALS OR RECOGNIZED MONOGRAM OF FILLER AND DATE OF FILLING (FOR BOMBS WITH MODEL NUMBER)
- 8 FILLED SERIES NUMBER
- 9 BATCH NUMBER, WHEN BOMBS ARE ISSUED FUZED AND CARTRIDGED

AREAS SHOWN DARK BROWN INDICATES BODY PHOSPHATED AND VARNISHED

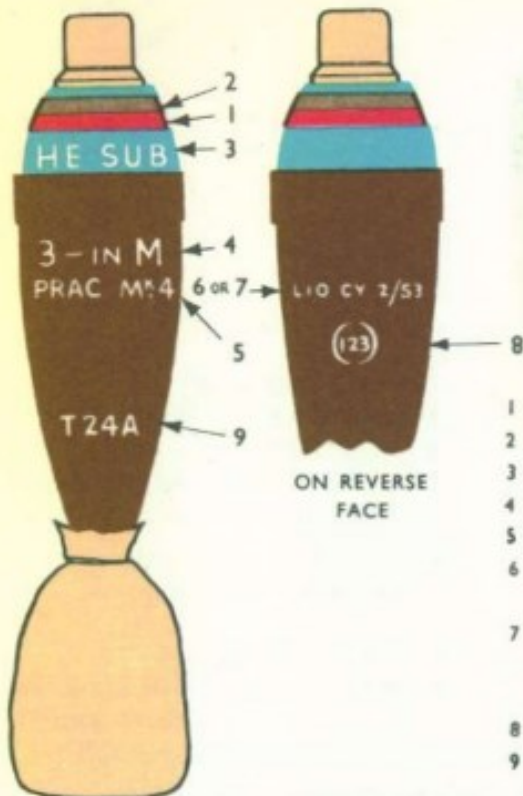
FIG.1

PRACTICE

AREAS SHOWN DARK BROWN INDICATES BODY PHOSPHATED AND VARNISHED

- 1 RED FILLING RING (WHEN CARTRIDGE IS FITTED)
- 2 BROWN RING (DENOTING CAST IRON)
- 3 NATURE OF FILLING
- 4 CALIBRE AND NATURE OF WEAPON
- 5 TYPE AND MARK, OR MODEL NUMBER, OF BOMB
- 6 ONE LINE CODE (METHOD OF FILLING) FOR BOMBS WITH MARK NUMBER
- 7 INITIALS OR RECOGNIZED MONOGRAM OF FILLER AND DATE OF FILLING (FOR BOMBS WITH MODEL NUMBER)
- 8 FILLED SERIES NUMBER
- 9 BATCH NUMBER, WHEN BOMBS ARE ISSUED FUZED AND CARTRIDGED

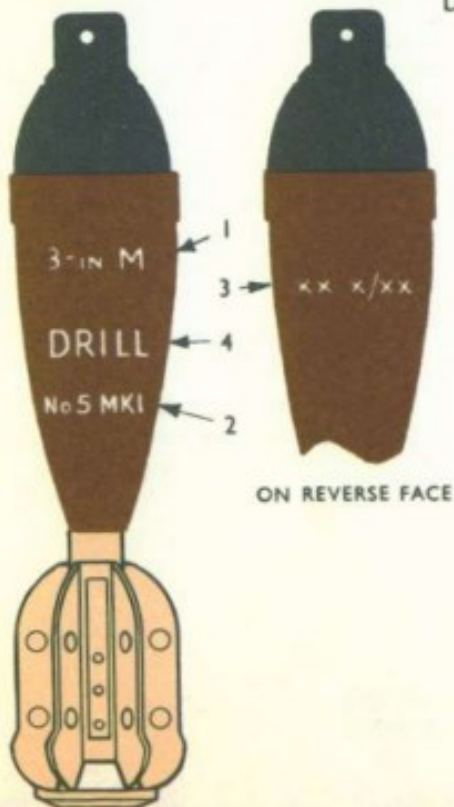
FIG.2

DRILL

AREAS SHOWN DARK BROWN INDICATES BODY PHOSPHATED AND VARNISHED

- 1 CALIBRE AND NATURE OF WEAPON
- 2 NUMBER, AND MARK, OF BOMB
- 3 RECOGNISED MONOGRAM OR INITIALS OF MANUFACTURER AND DATE OF MANUFACTURE (MONTH AND YEAR)
- 4 TYPE OF BOMB

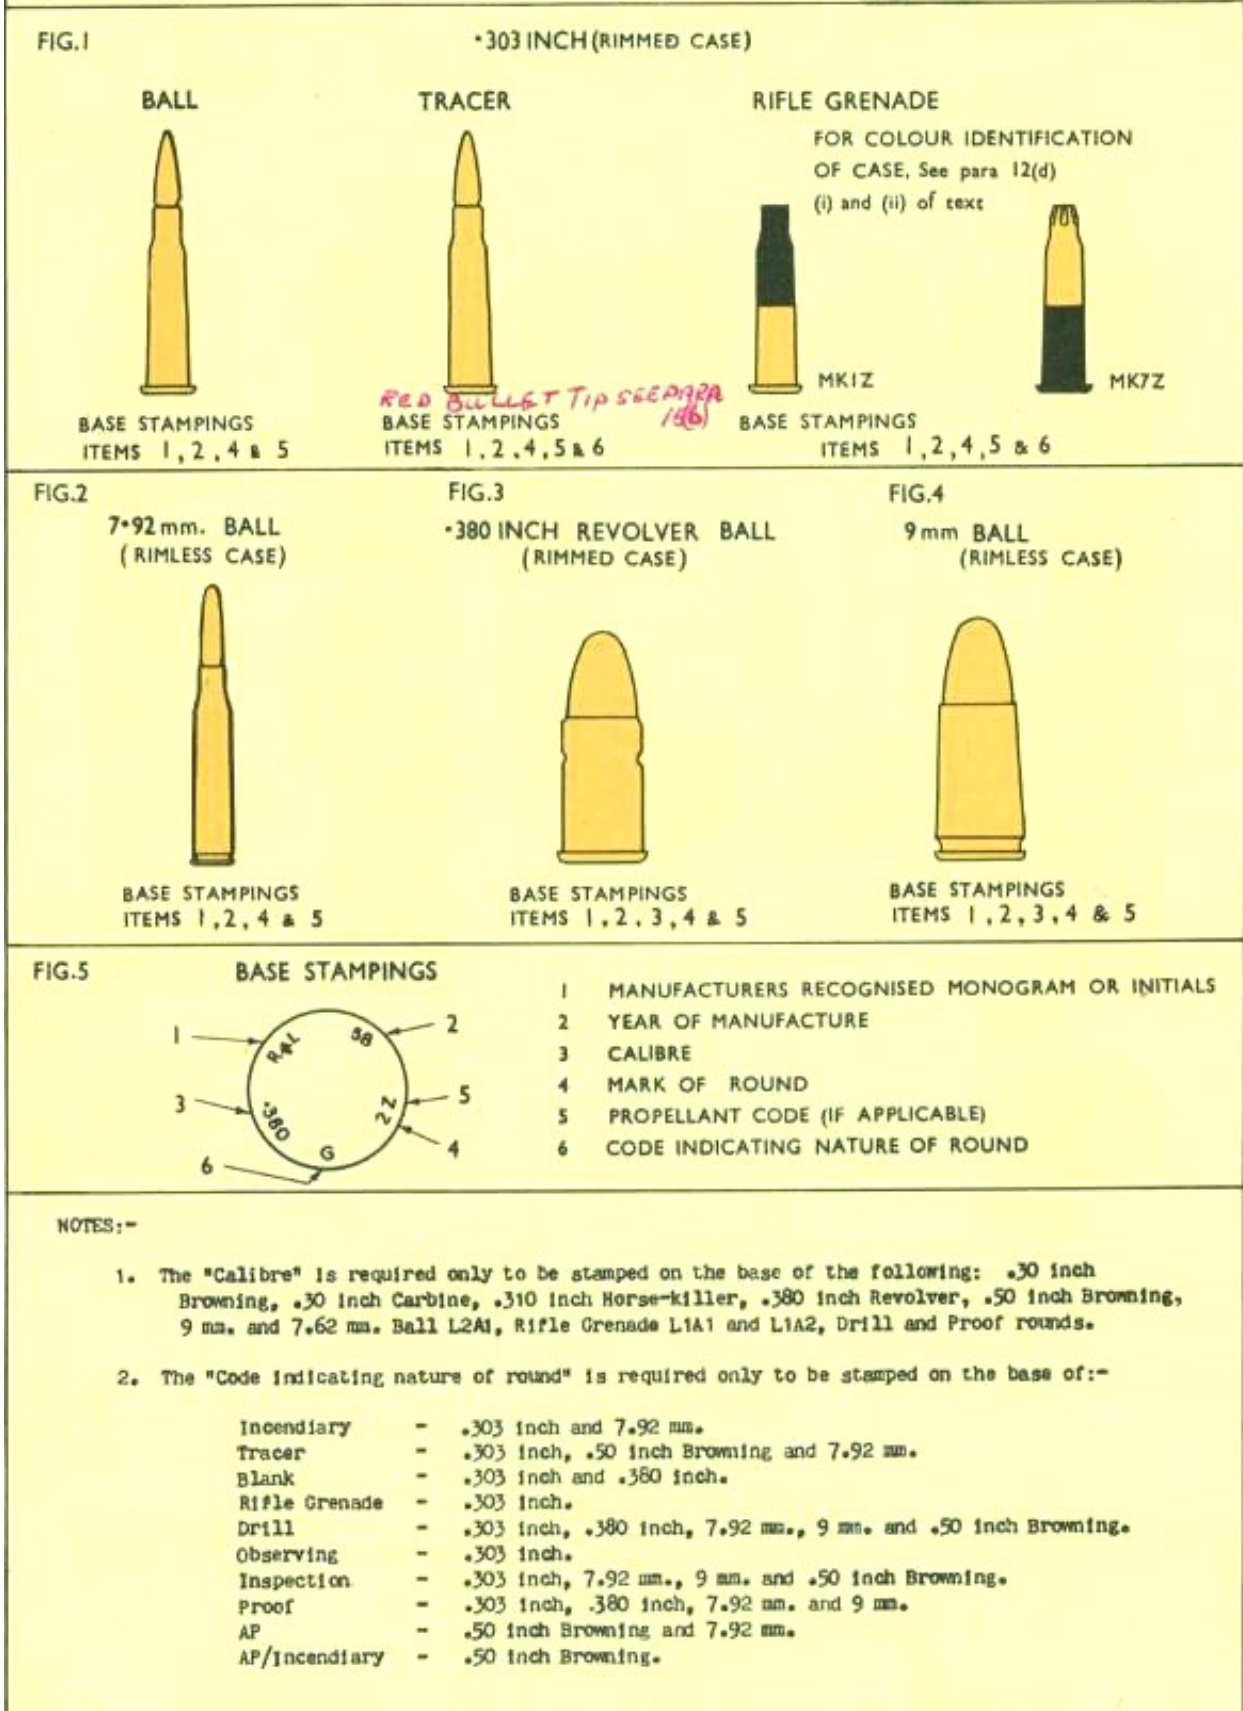
TYPICAL IDENTIFICATION MARKINGS ON S.A.A. (SMALL ARMS AMMUNITION)

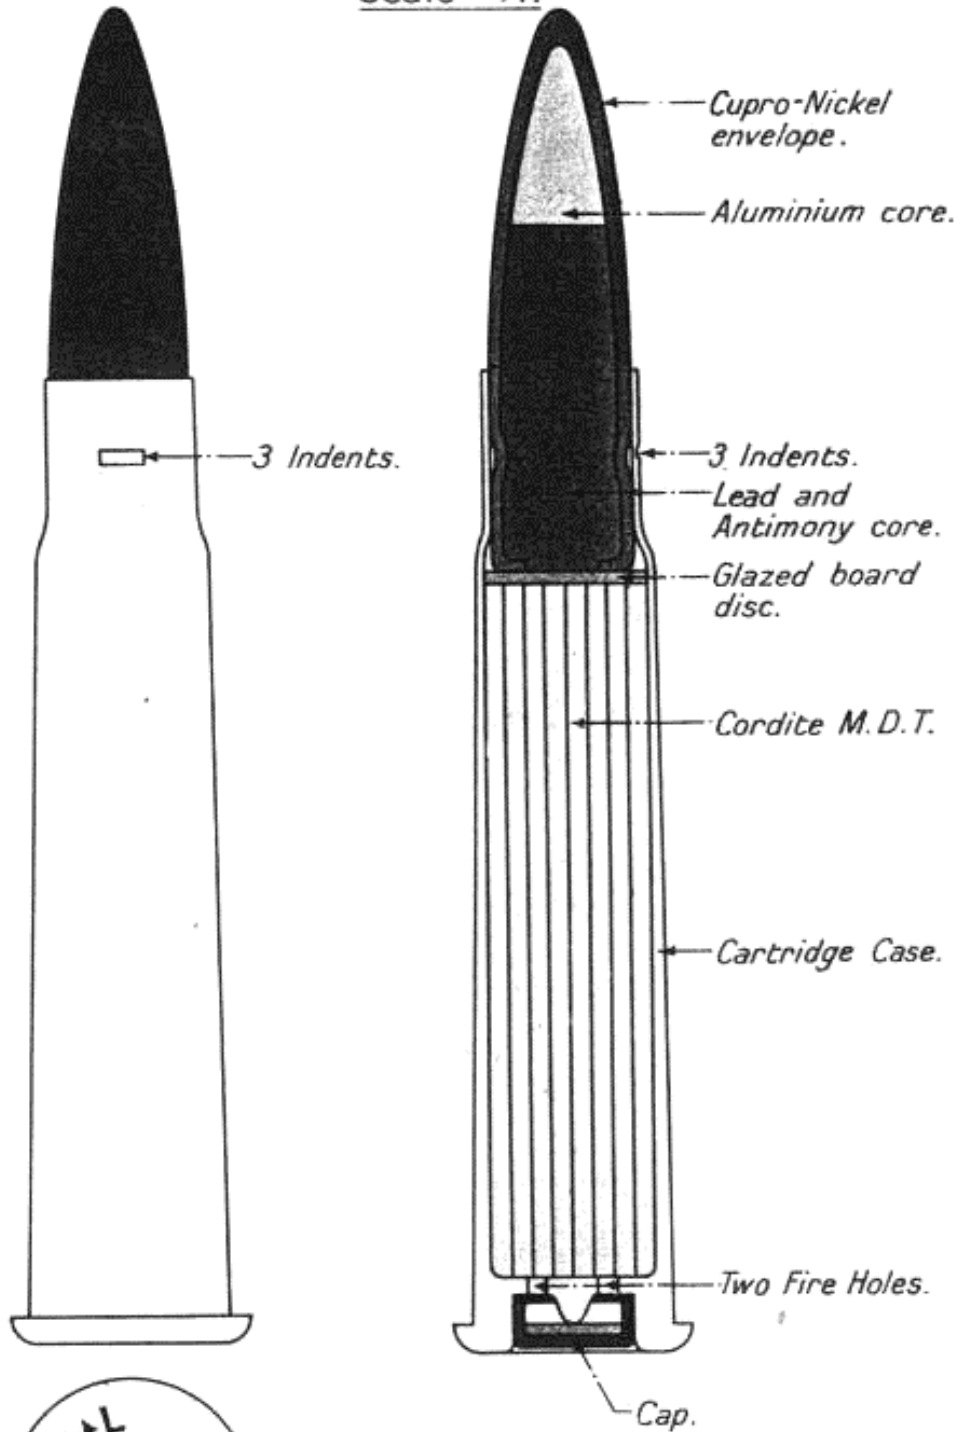
**CARTRIDGE, S. A., BALL, .303 INCH.
MARK VII.**

Scale = $\frac{2}{1}$.

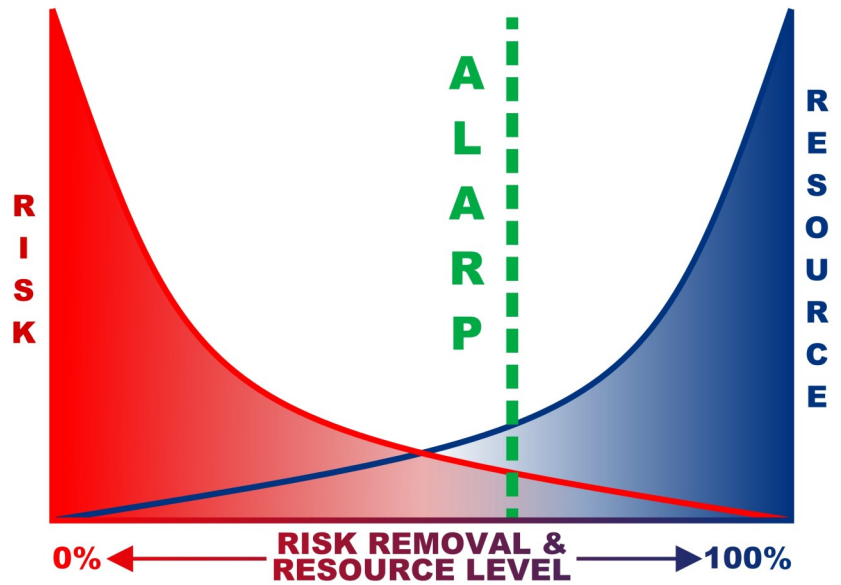
ALARP Resource Graph

ALARP has particular connotations in UK Health and Safety law and the core concept of what is "reasonably practicable". This involves weighing a risk against the effort, time and costs needed to control it. For a risk to be reduced in line with ALARP it must be possible to demonstrate that the cost involved in reducing the risk further would be "grossly disproportionate" to the benefit gained. The ALARP principle arises from the fact that it would be possible to spend infinite time, effort and money attempting to reduce a risk to zero. Importantly, it is not simply a quantitative measure of benefit against detriment but a common practice of "judgment" of the balance of risk and social benefit.
