CAMBOURNE TO CAMBRIDGE

Appendix TR5.1: Aquatic Ecology Report 2022

Aquatic Ecology Report 2022

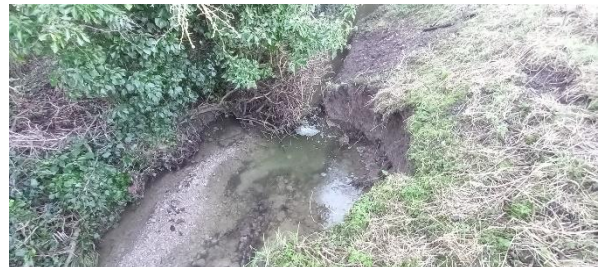
Figure TR5.1.A-6 – Bank Erosion

- 4.2.5. The substrate was variable, with some areas of coarse sediment (boulder, pebble and gravel), but the majority consisted of fine sediment. Channel morphology was varied, containing gravel beds and deeper pools. Bank erosion and poaching was observed, a possible consequence of walkers, dogs and cyclists crossing the brook on the existing footbridge, and wildlife crossing the brook.

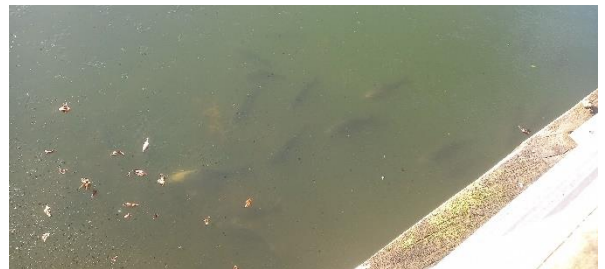
Figure TR5.1.A-30 – Cyprinids within Lake

- 4.2.43. West Cambridge Lake contained large cyprinids (members of the carp family) with a dark colouration. An estimated 30-40 individuals of varying age classes were observed at the water's surface. These fish are likely stocked for an angling or ornamental purpose and would not occur here naturally.
