Cambridge South East Transport Scheme

Contaminated Land Risk Assessment - Historical Landfills

Project:	Cambridge South East Transport Scheme		
Our reference:	403394-MMD-ENV-00-RA-EN-0998		
Prepared by:	H Small	Date:	24 June 2021
Approved by:	J Montgomery	Checked by:	J Southall
Subject:	Contaminated Land Risk Assessment – Historical Landfills

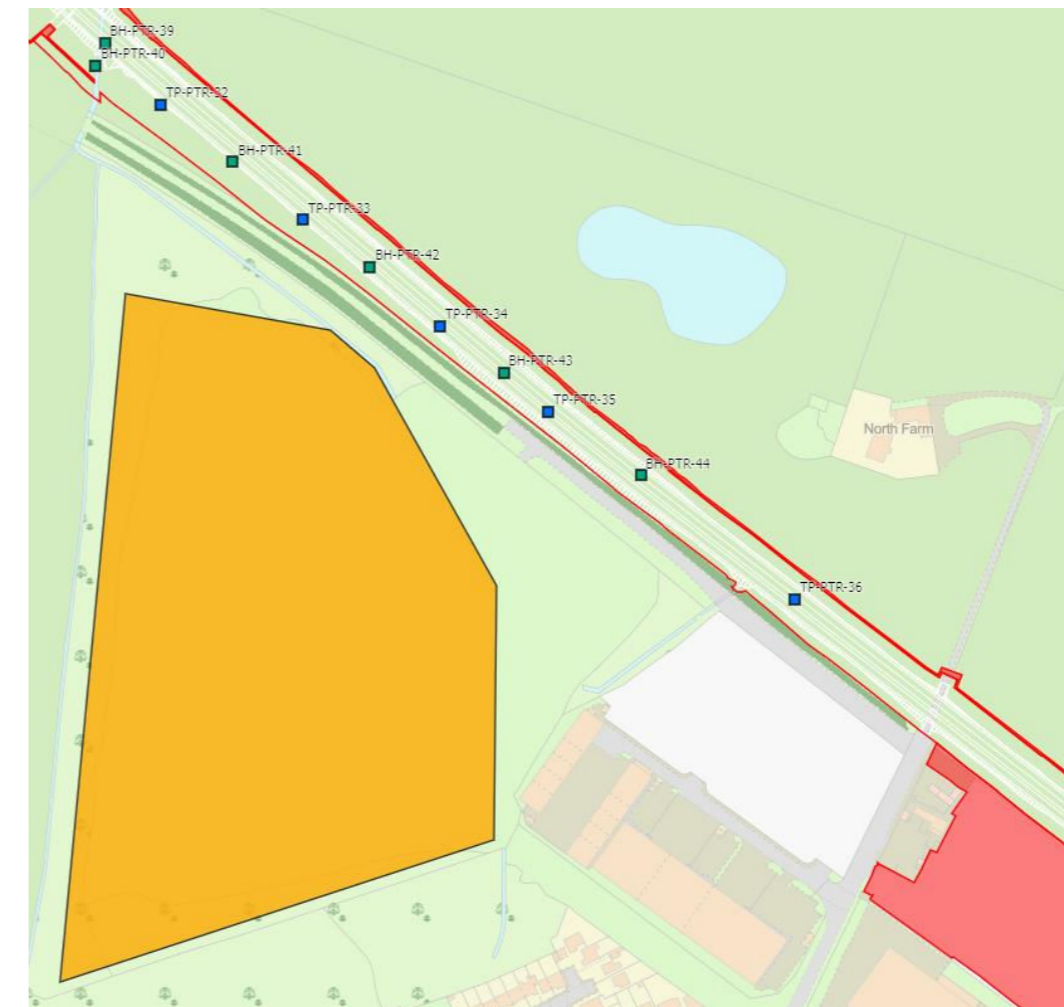
Figure 2.1: Sindalls Landfill

Note: orange polygon indicates historic landfill site. Red line indicates red line boundary of scheme. Red polygons indicate temporary land take areas.

As the majority of the route is located in greenfield areas, the main identified source of contaminated land relates to three historical landfills located adjacent to the scheme. The details of these landfills are shown in Table 1-1 below. The location of these can also be seen in Figure 2.1, Figure 2.2 and Figure 2.3.

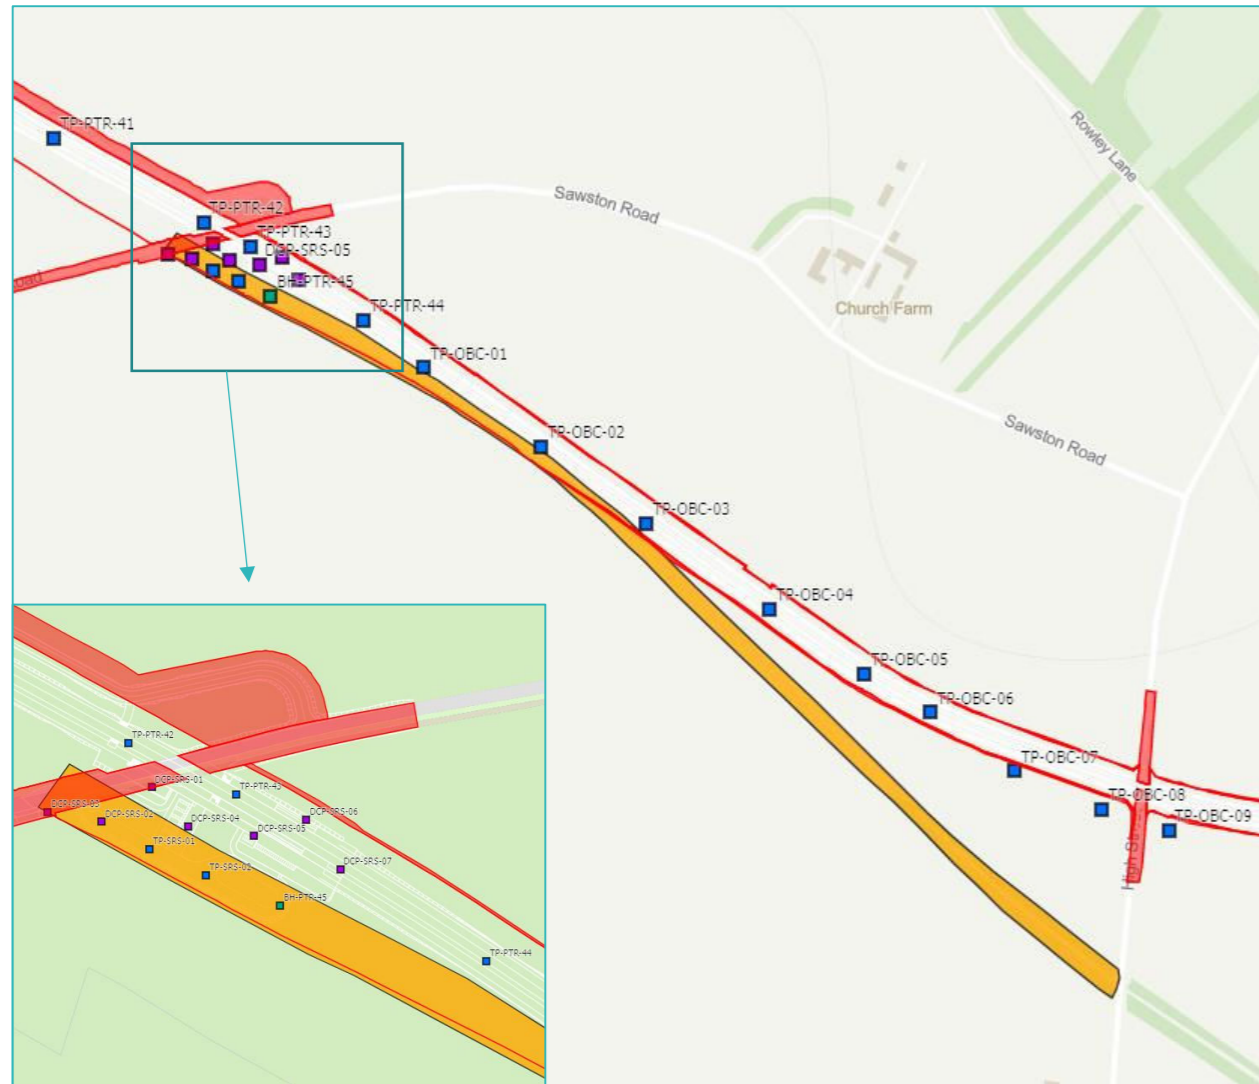
Figure 2.2: Home Farm Landfill – 1

Note: orange polygon indicates historic landfill site. Red line indicates red line boundary of scheme. Red polygons indicate temporary land take areas.

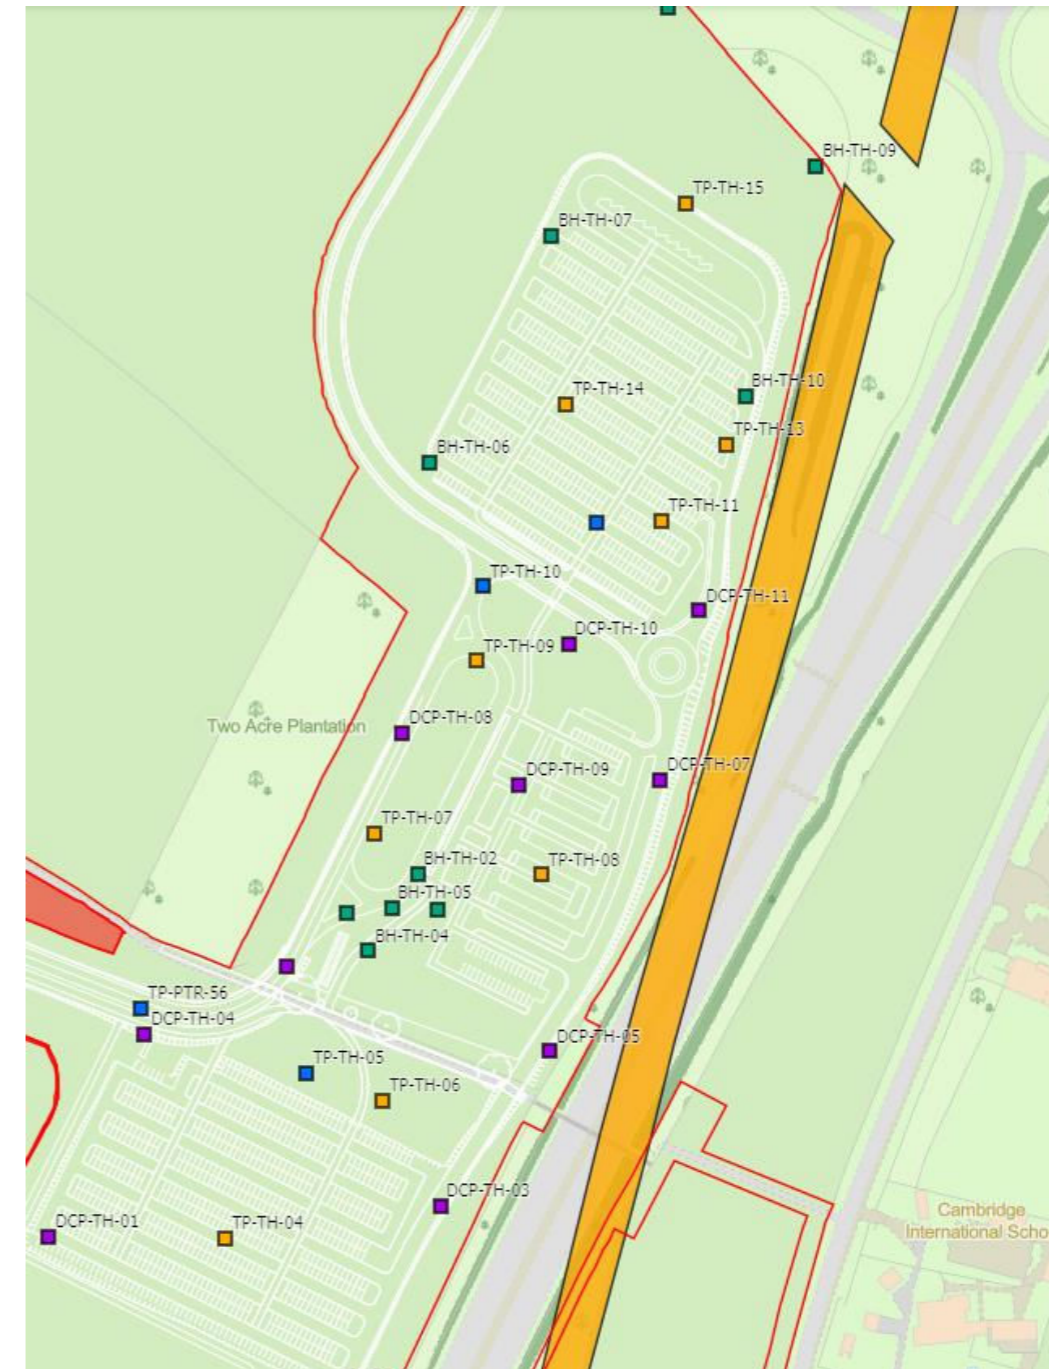
Figure 2.3: Home Farm Landfill - 2

Note: orange polygon indicates historic landfill site. Red line indicates red line boundary of scheme. Red polygons indicate temporary land take areas.

The linear Home Farm 2 historical landfill appears to cross the River Granta and other drains located east of the A11 (see Figure 2.3). However, the river is not affected by the landfill (ie. not covered by the landfill) as it is on an embankment in this area.
