# CAMBOURNE TO CAMBRIDGE

Environmental Statement

Technical Report 5: Ecology, Appendix 5.12:  
Otter and Water Vole Survey (Draft)

Otter and Water Vole Survey (Draft)

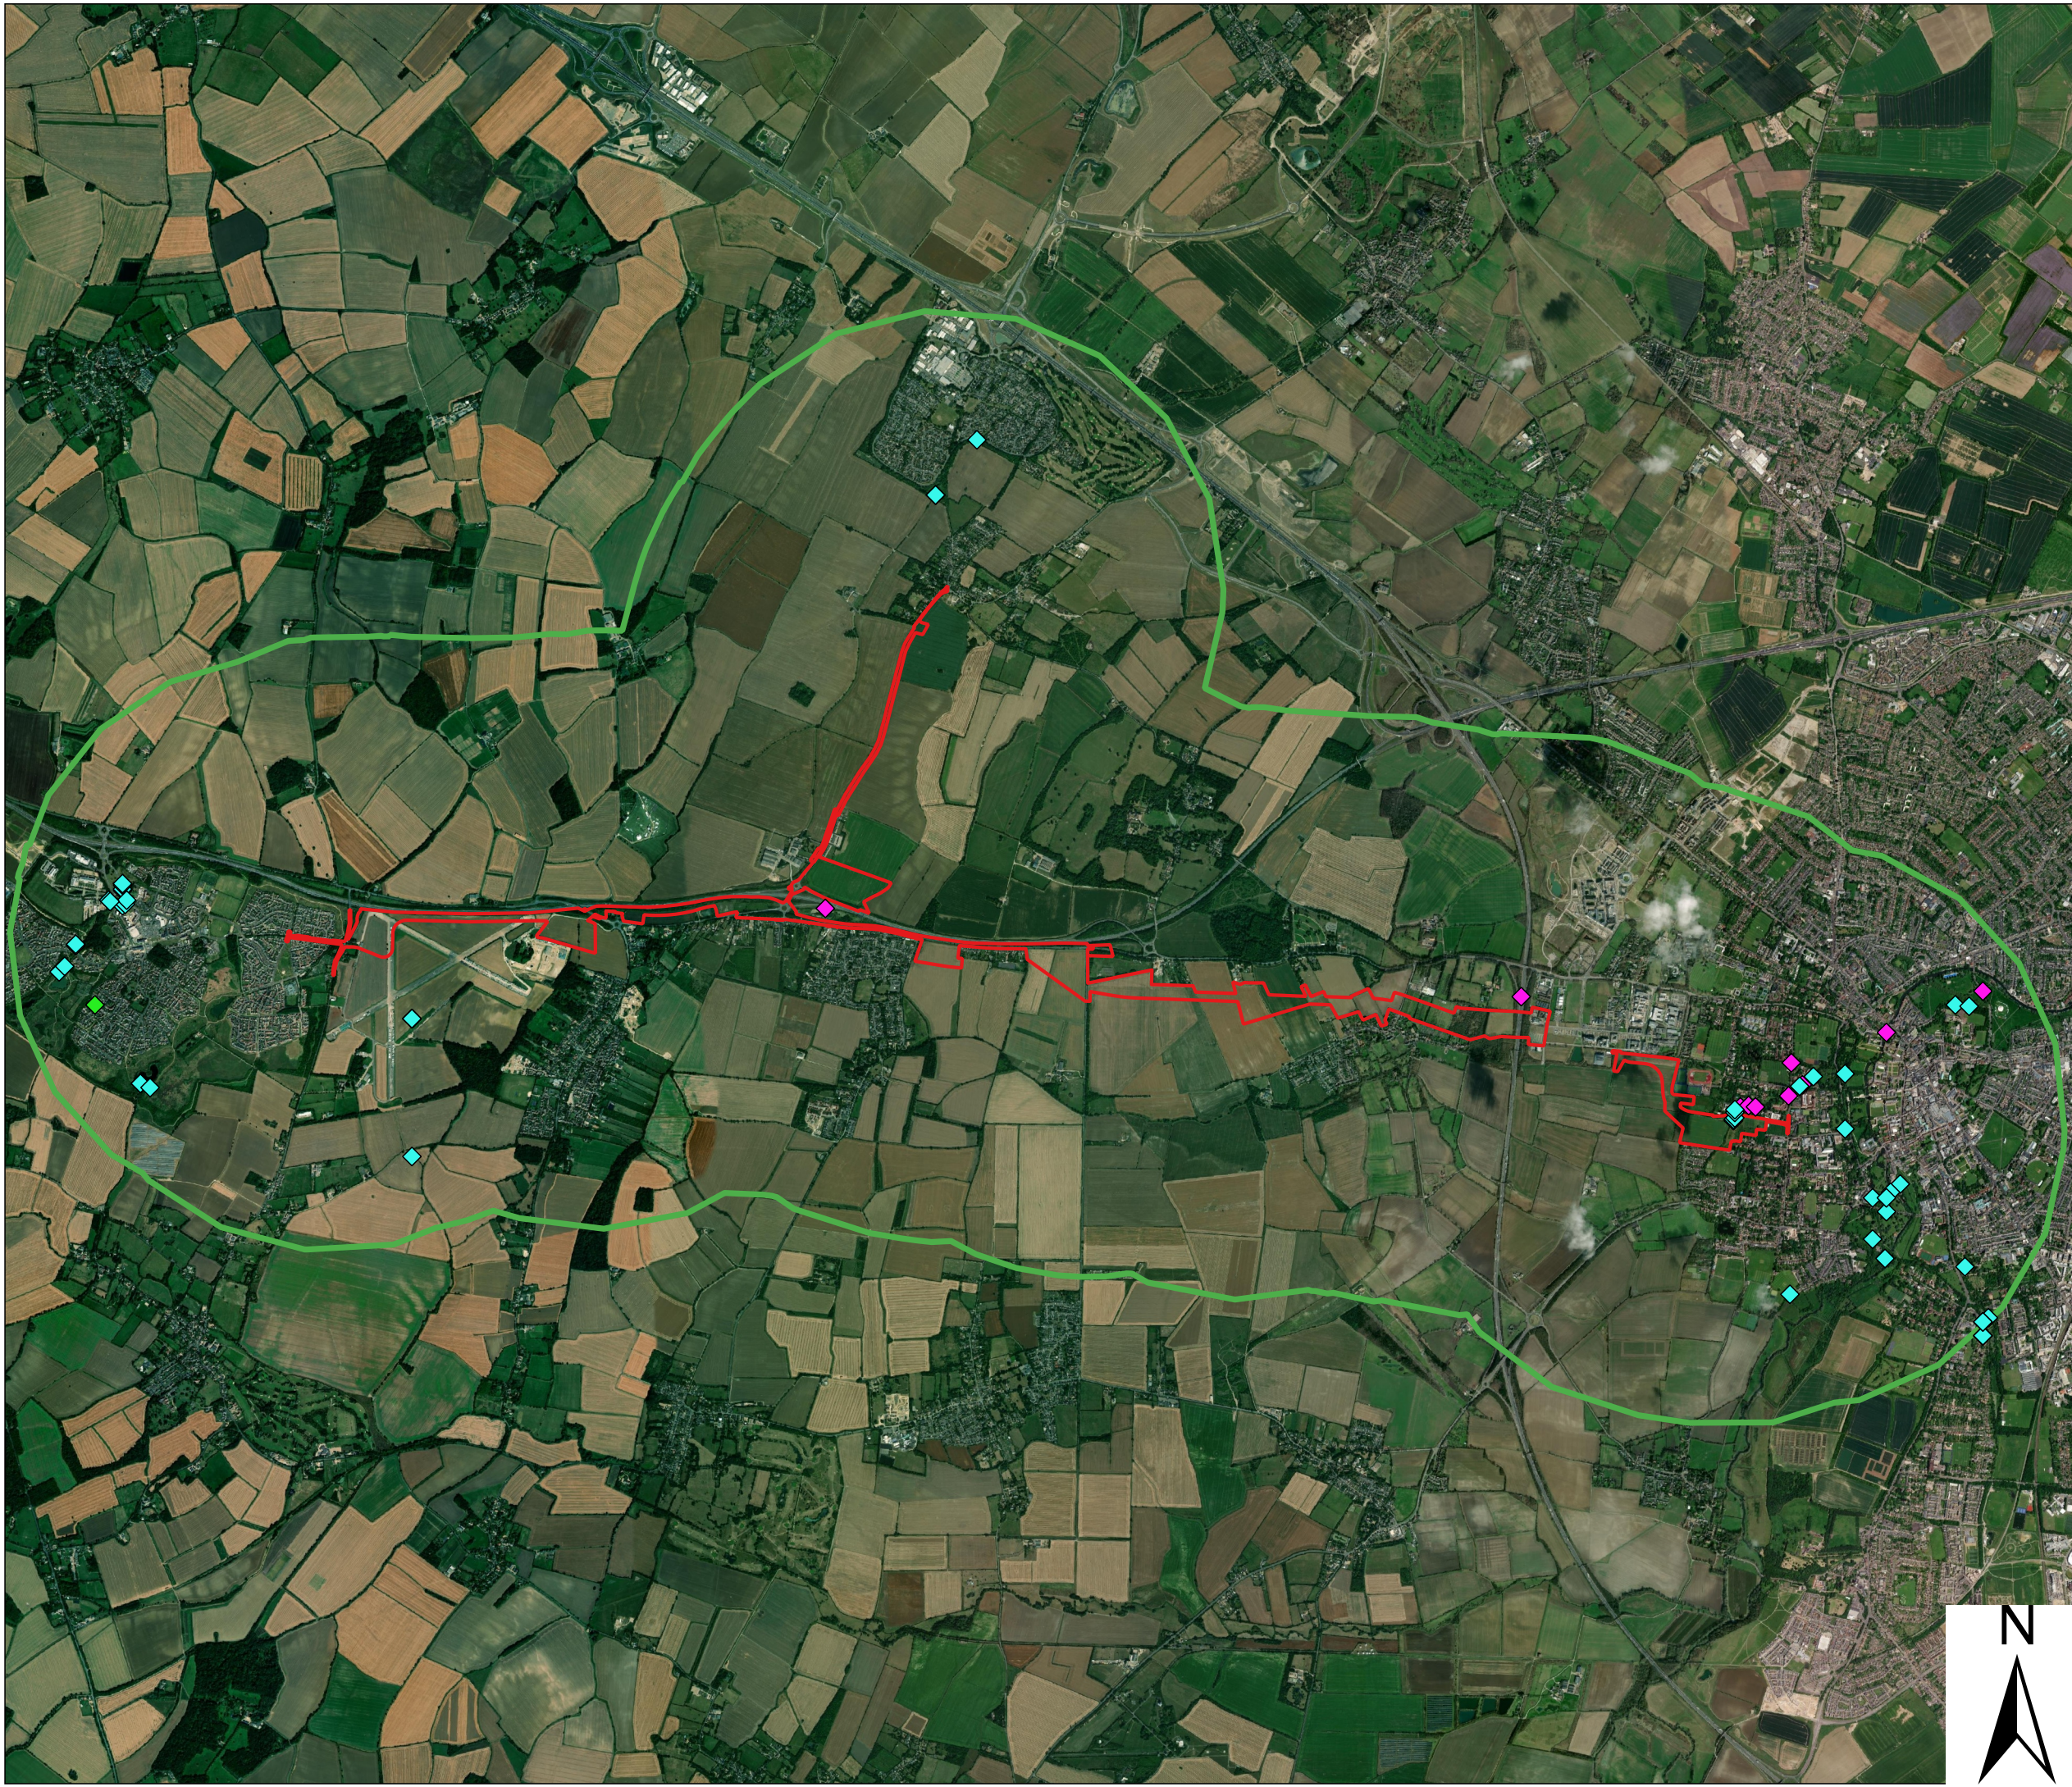
## **2022 Desk Study Results**

- Scheme Boundary
- 2km Survey Area

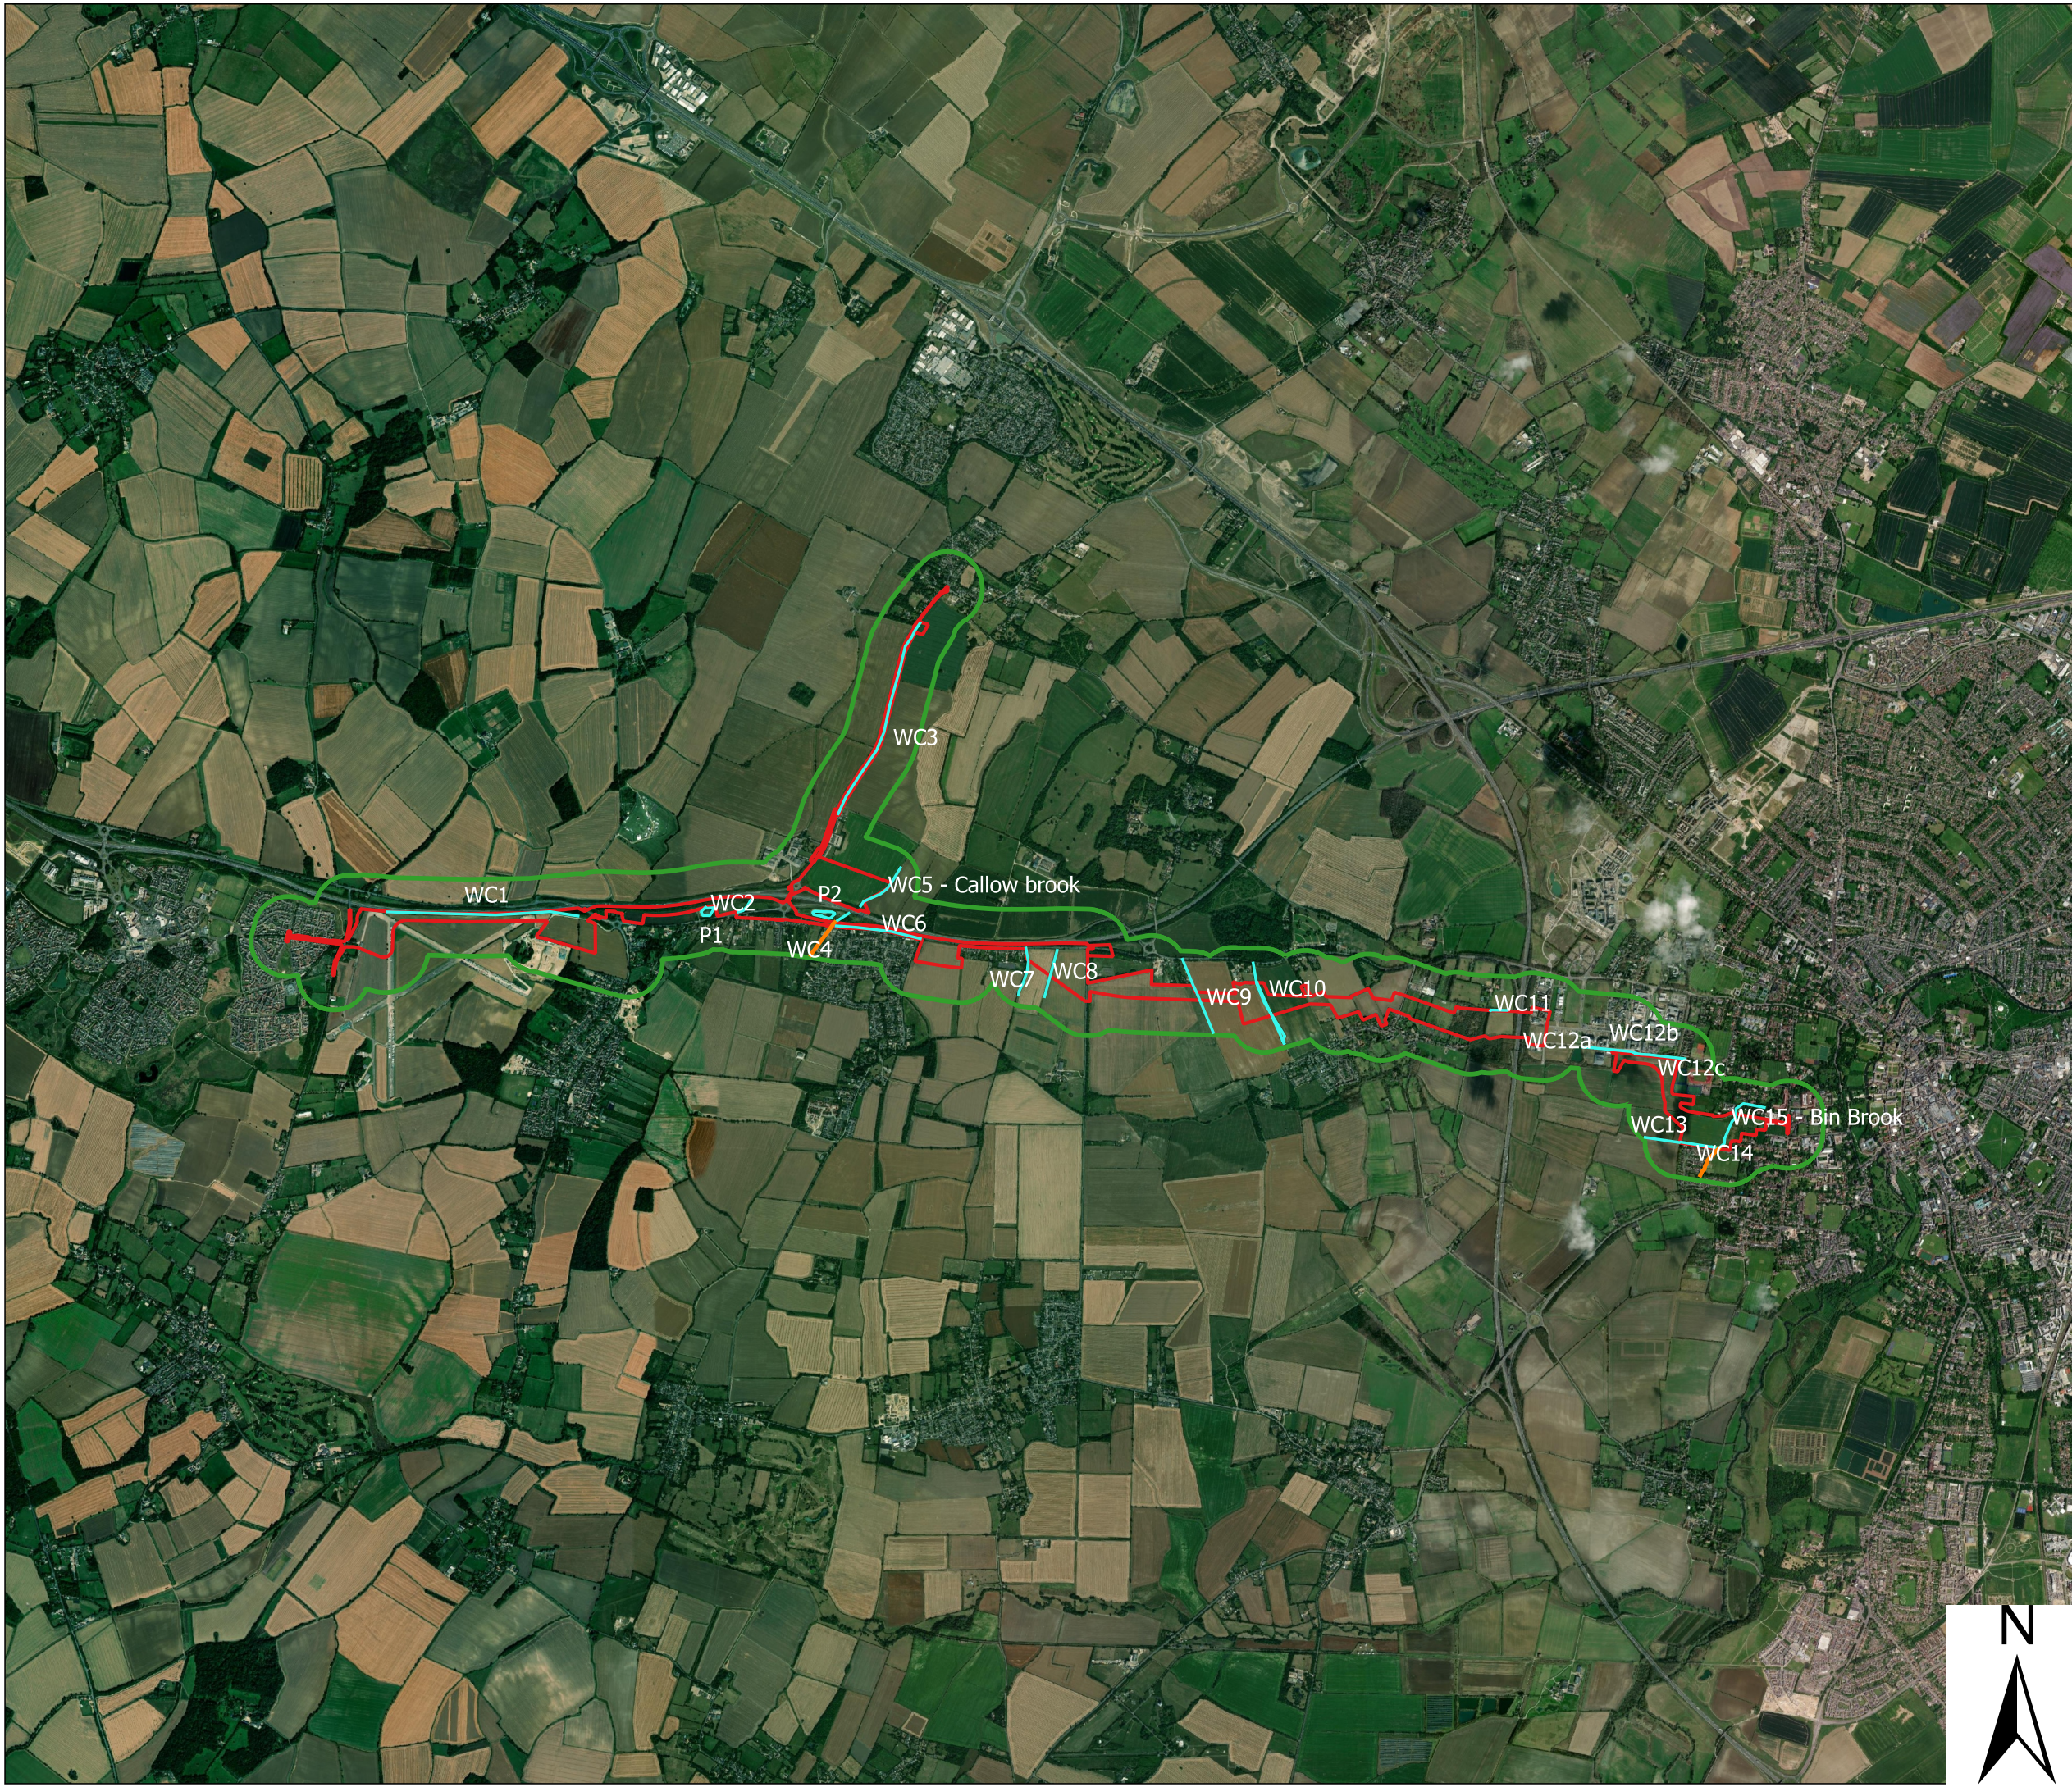
**Otter and Water Vole Survey Area**

- Scheme Boundary
- 250m Survey Area
- Waterbodies
- Waterbodies Not Surveyed

- 3.2.5. The Survey Area was informed by guidance in The Water Vole Mitigation Handbook (Dean, Strachan, Gow, & Andrews, 2016) which recommends a field survey area of between 200m and 500m upstream and downstream for a scheme with the potential for permanent impacts affecting more than 50m of watercourse. The Survey Area comprised 250m sections up and downstream from the Scheme Alignment. This also included all directly connected water features and associated riparian habitat. The Survey Area extents are shown in **Annex 5.12.2**.

- 3.4.3. The northern section of WC4 which was accessible for survey (as shown in **Annex 5.12.2**) could only be surveyed from specific points due to the presence of dense scrub alongside the channel, and sludge throughout the channel. This made a full assessment of field signs difficult however, this section is joined to Callow Brook (which was found to have numerous Water Vole field signs) via culvert beneath the A428 road. To overcome this limitation, Water Vole presence will be assumed throughout this watercourse. The watercourse is not considered suitable for Otter.

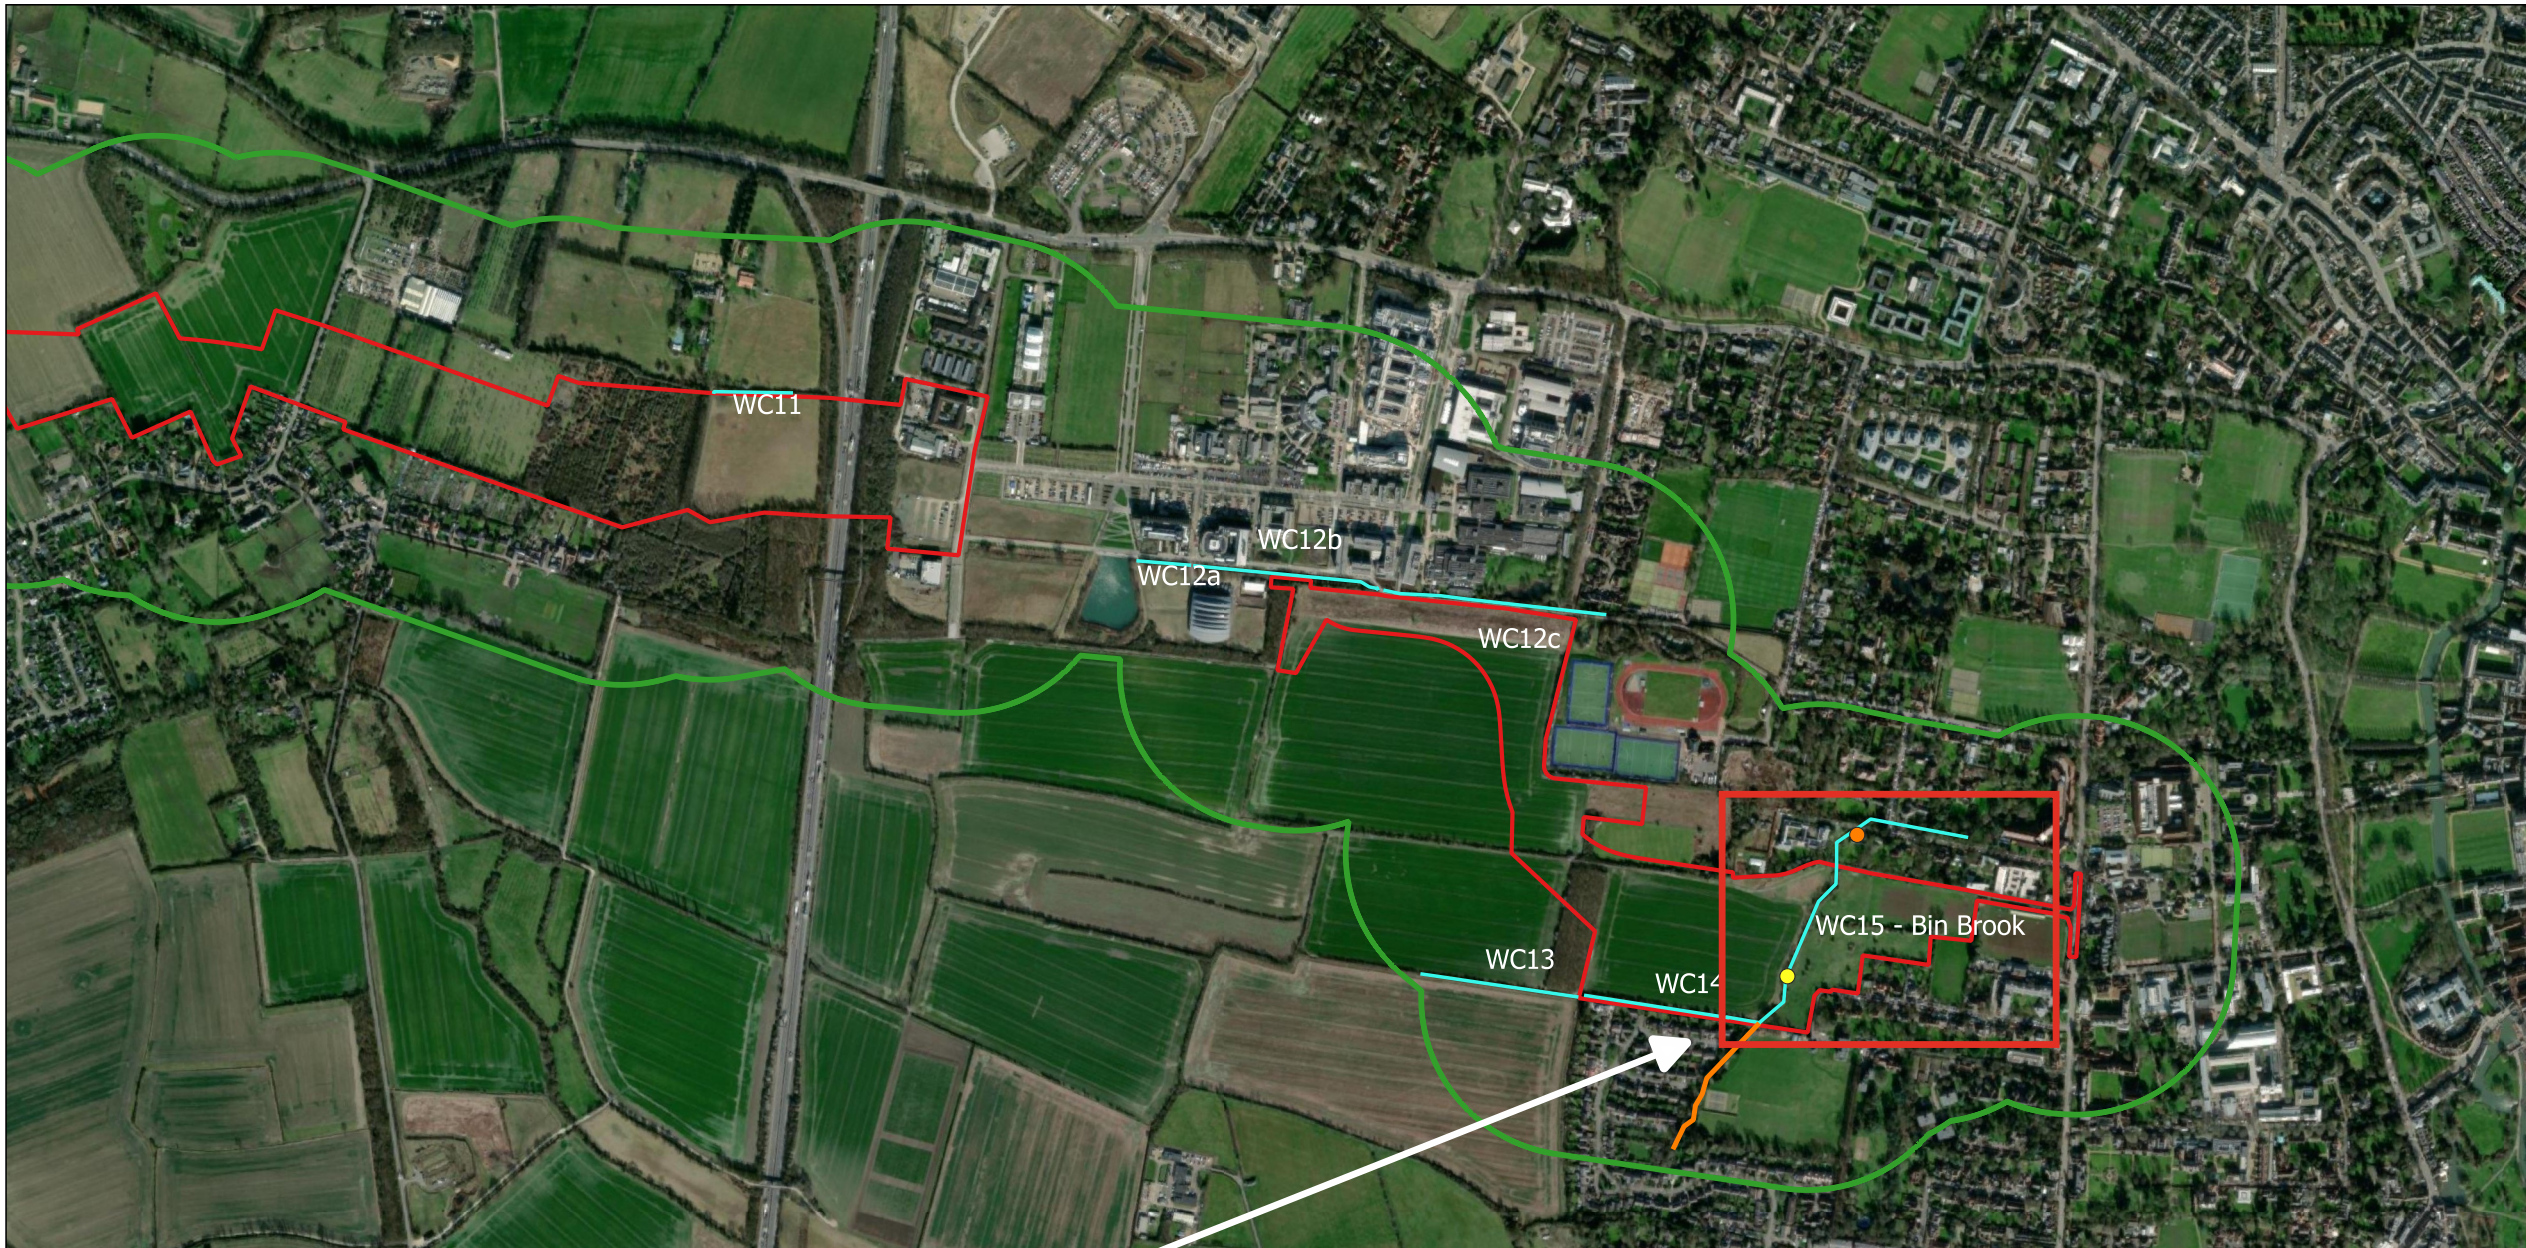
TITLE: **Otter Survey Results - East**

- Scheme Boundary
- 250m Survey Area
- Waterbodies
- Waterbodies Not Surveyed
